# International Aircraft Materials Fire Test Working Group

## Update on Flammability Testing of Magnesium Alloy Components

Date: October 21, 2009

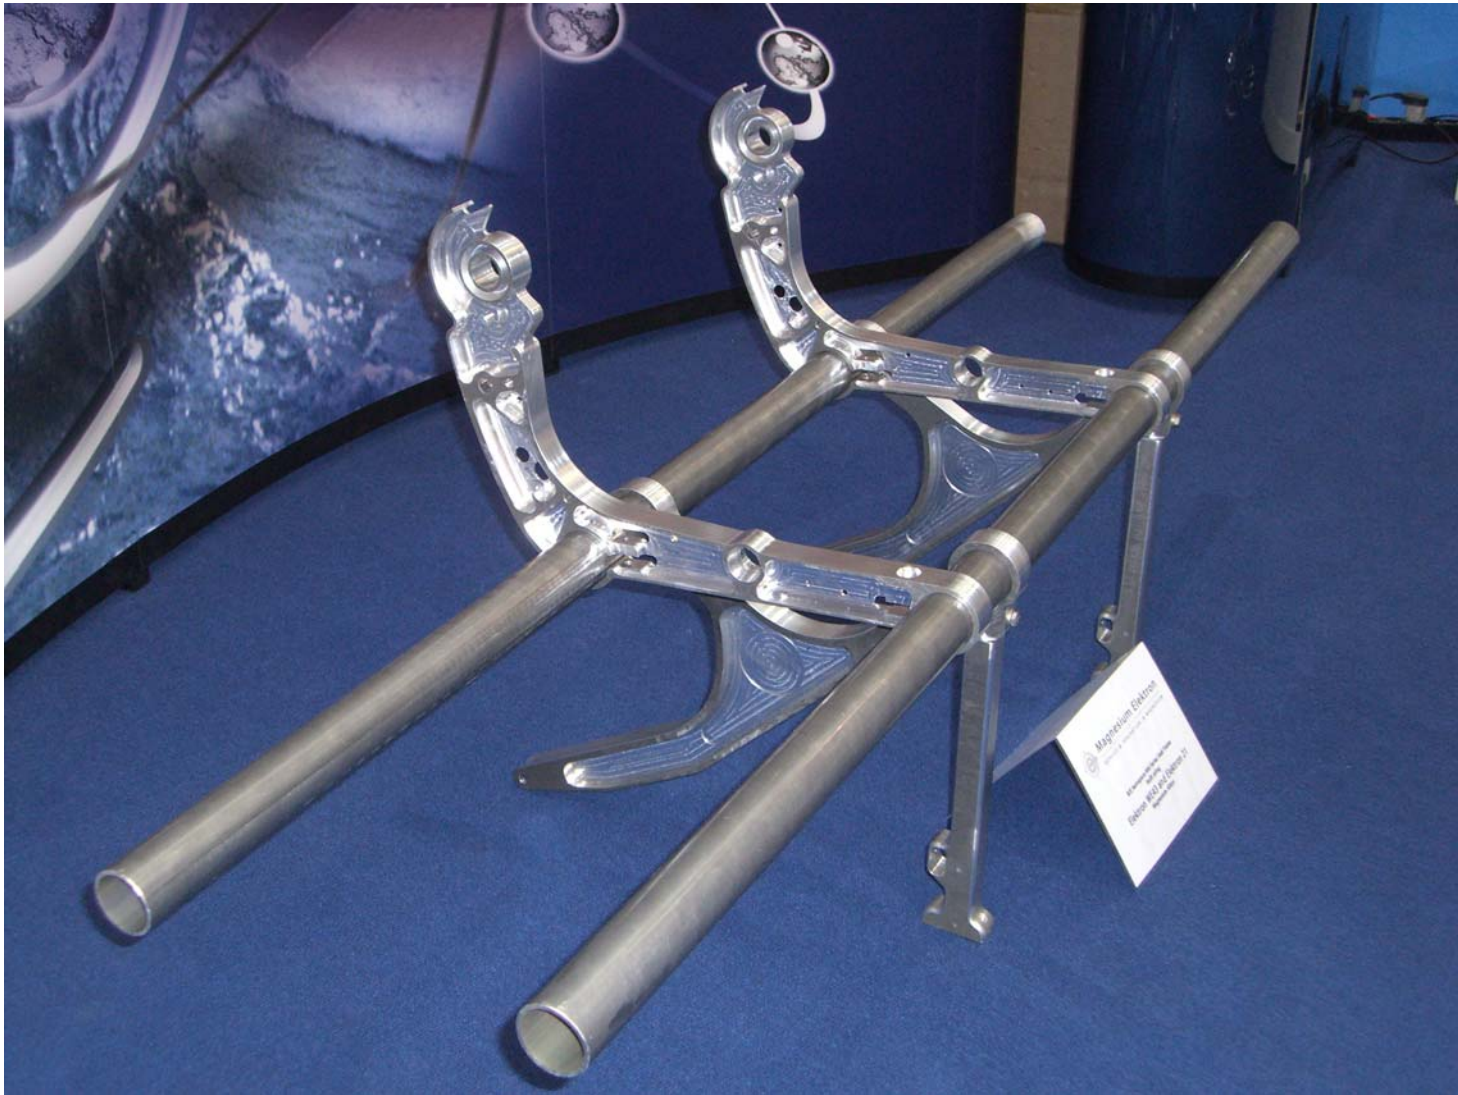
# Primary Seat Components

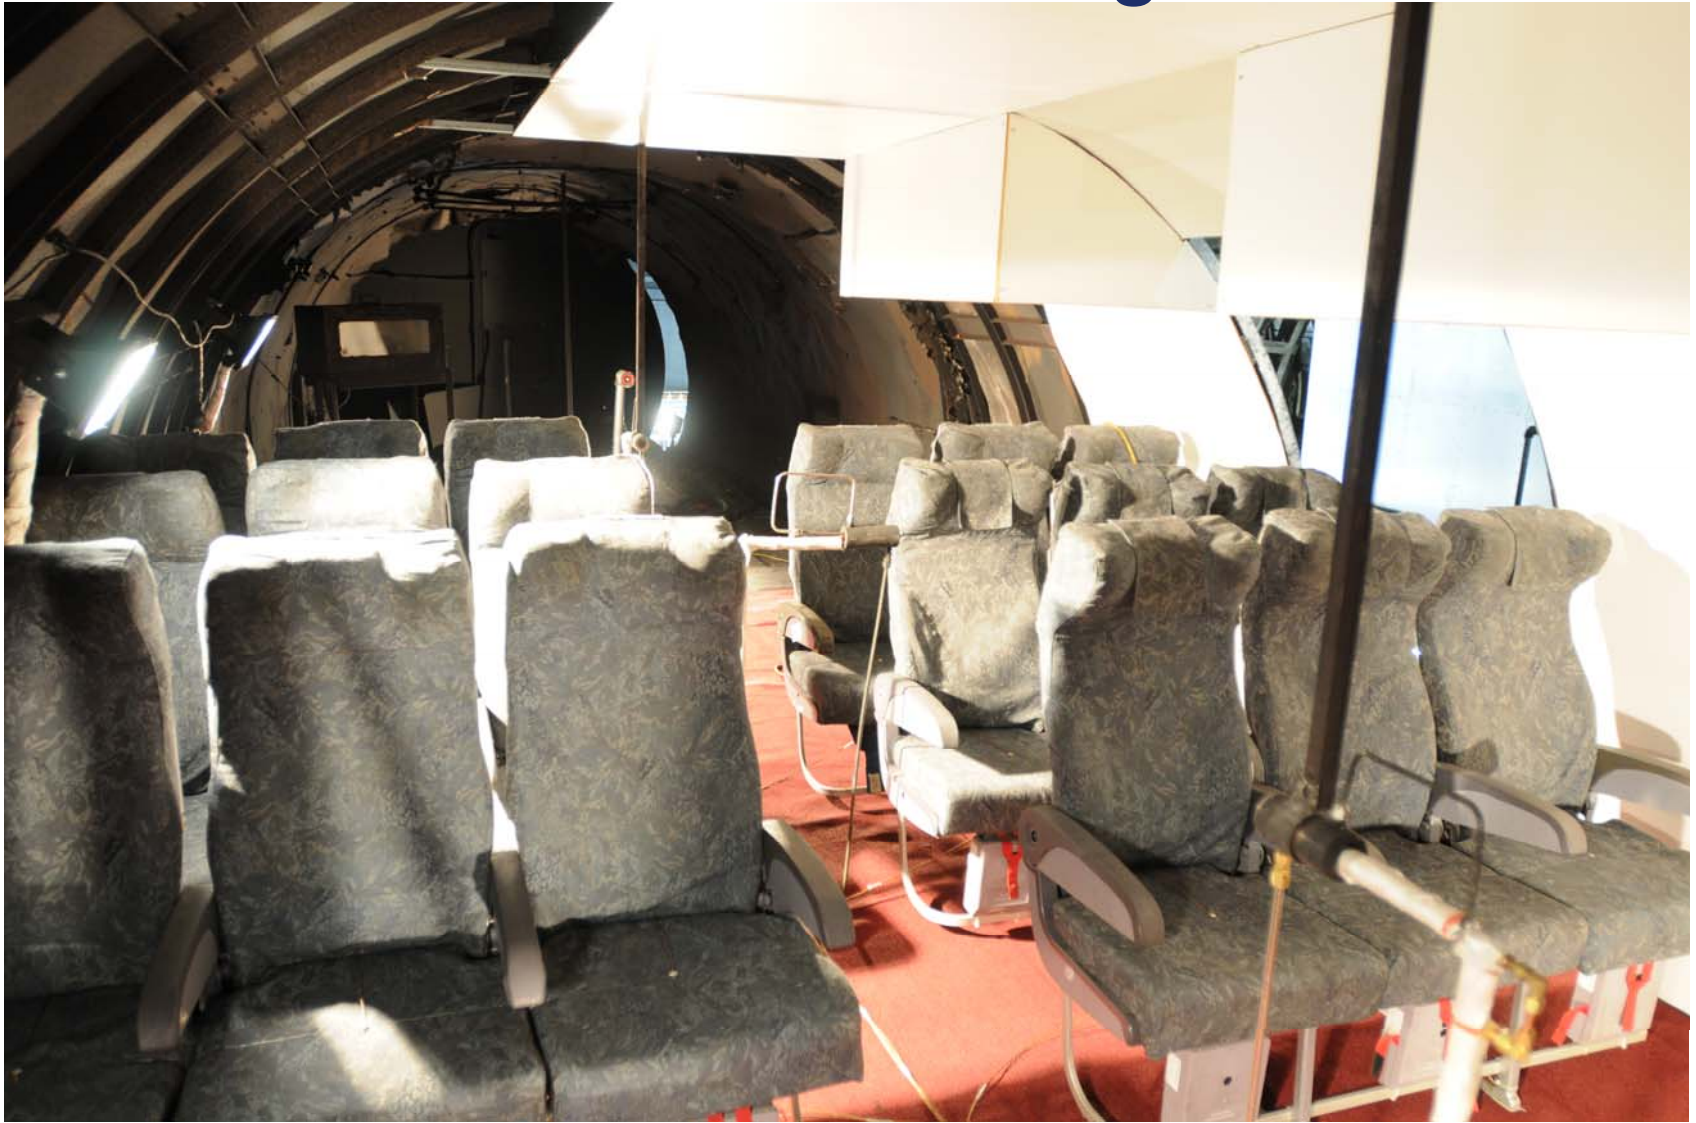
# Baseline 1 Test Configuration

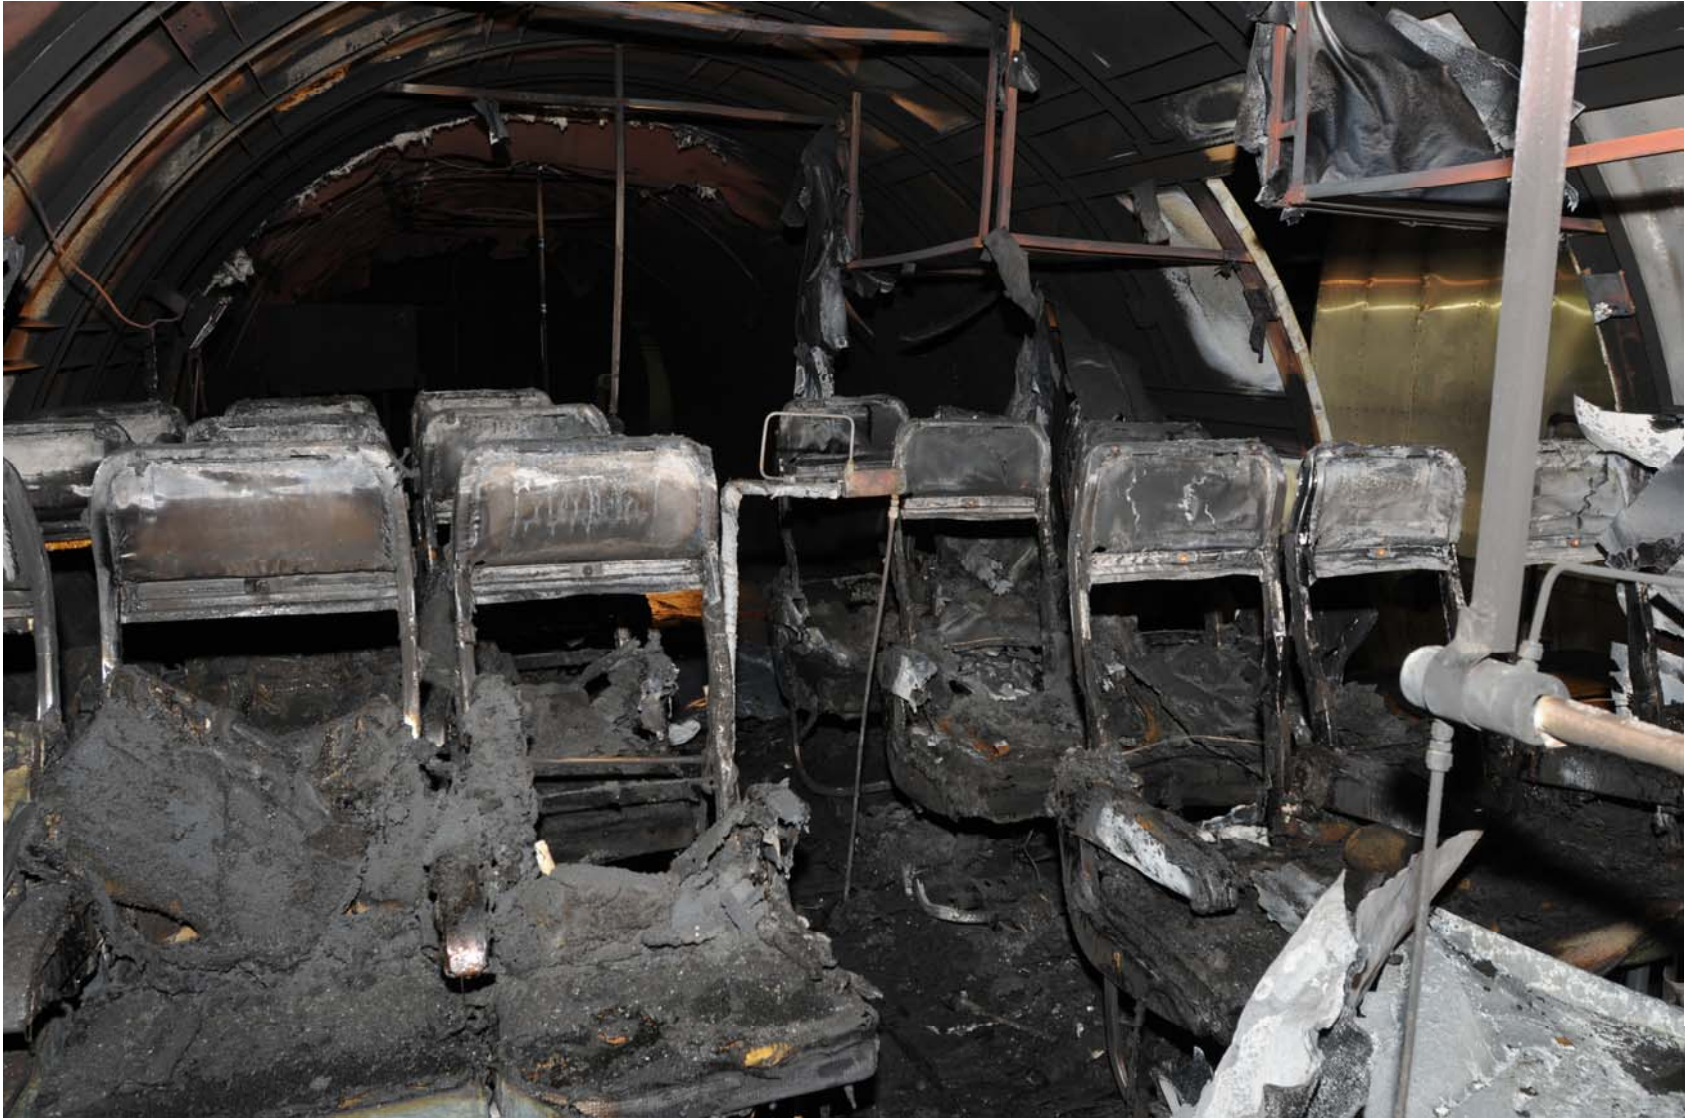
# Baseline 1 Test Result

Test terminated at 3 minutes

Incapacitation reached in less than 3 minutes

Seat backs (cushions, covers, plastics) completely consumed

Seat bottom cushions on LHS heavily involved in fire

Minimal melting of primary seat structure

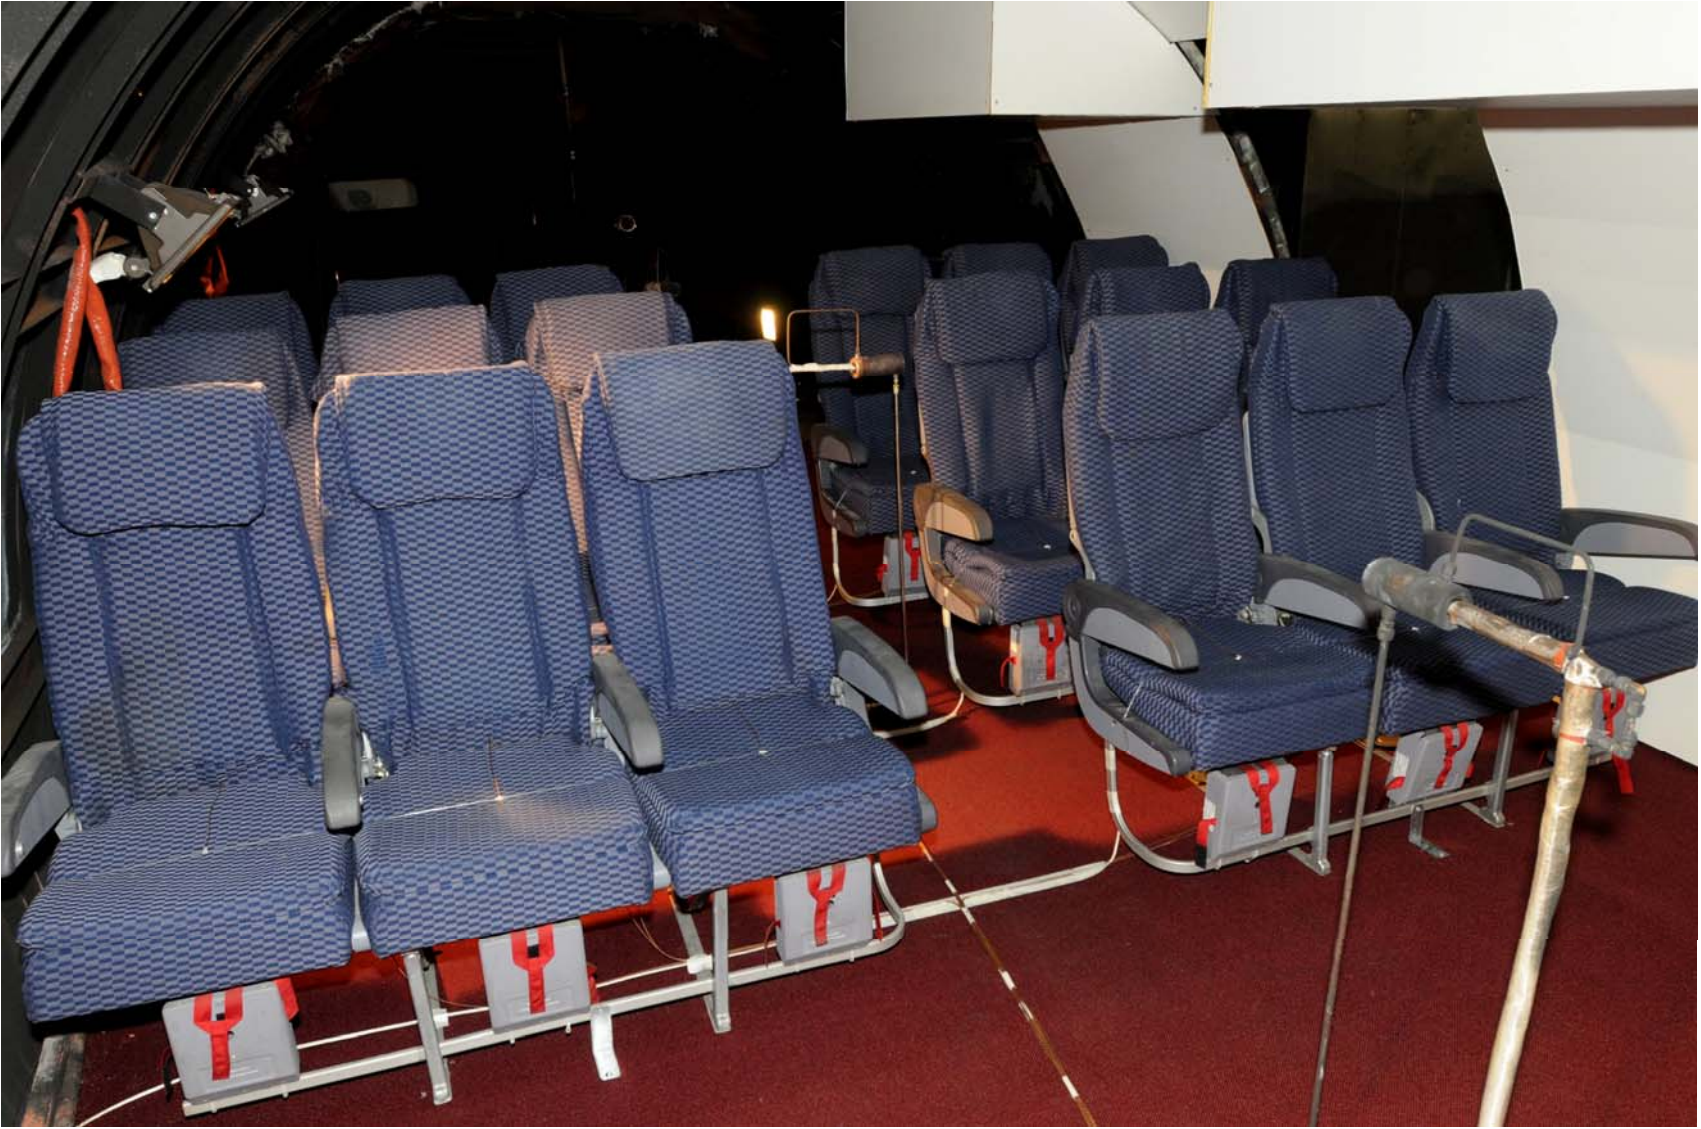
# Baseline 2 Test Configuration

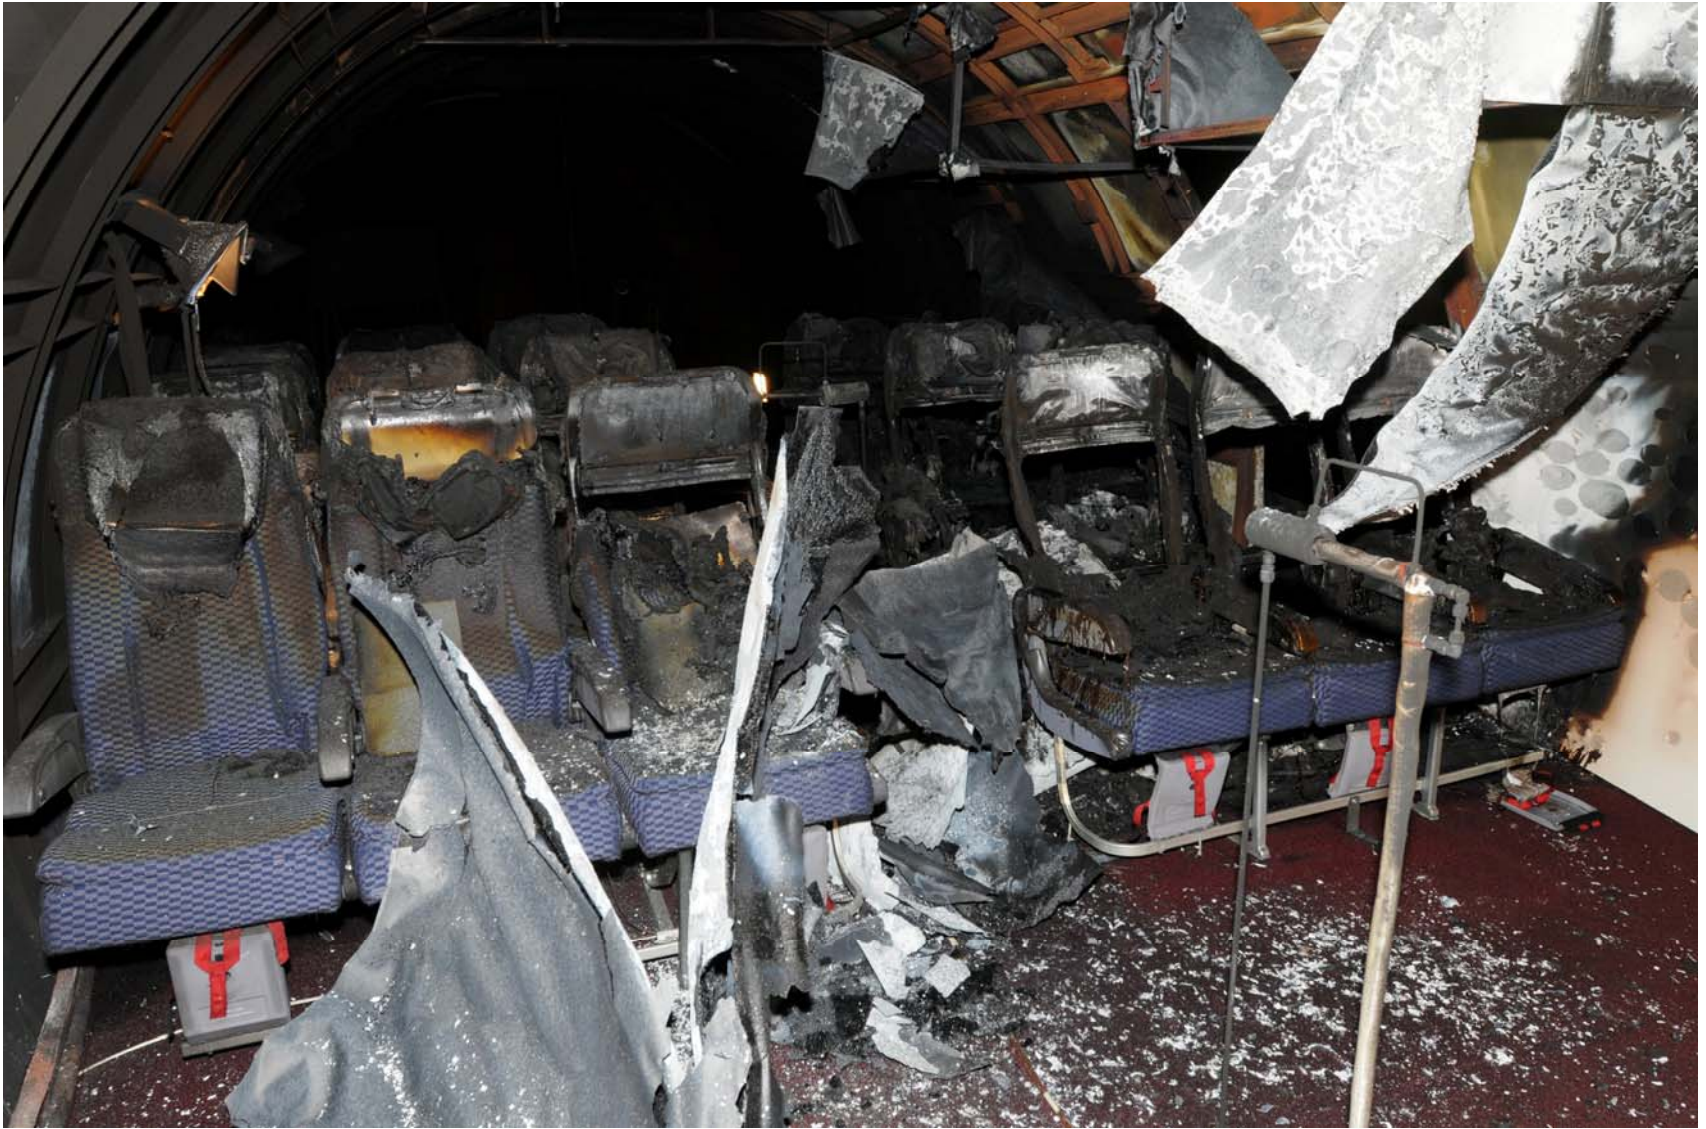
# Baseline 2 Test Results (untouched)

Test terminated at 5 minutes 30 seconds

Incapacitation still reached in less than 3 minutes

Seat backs (cushions, covers, plastics) completely consumed

Seat bottom cushions on LHS heavily involved in fire

Minimal melting of primary seat structure

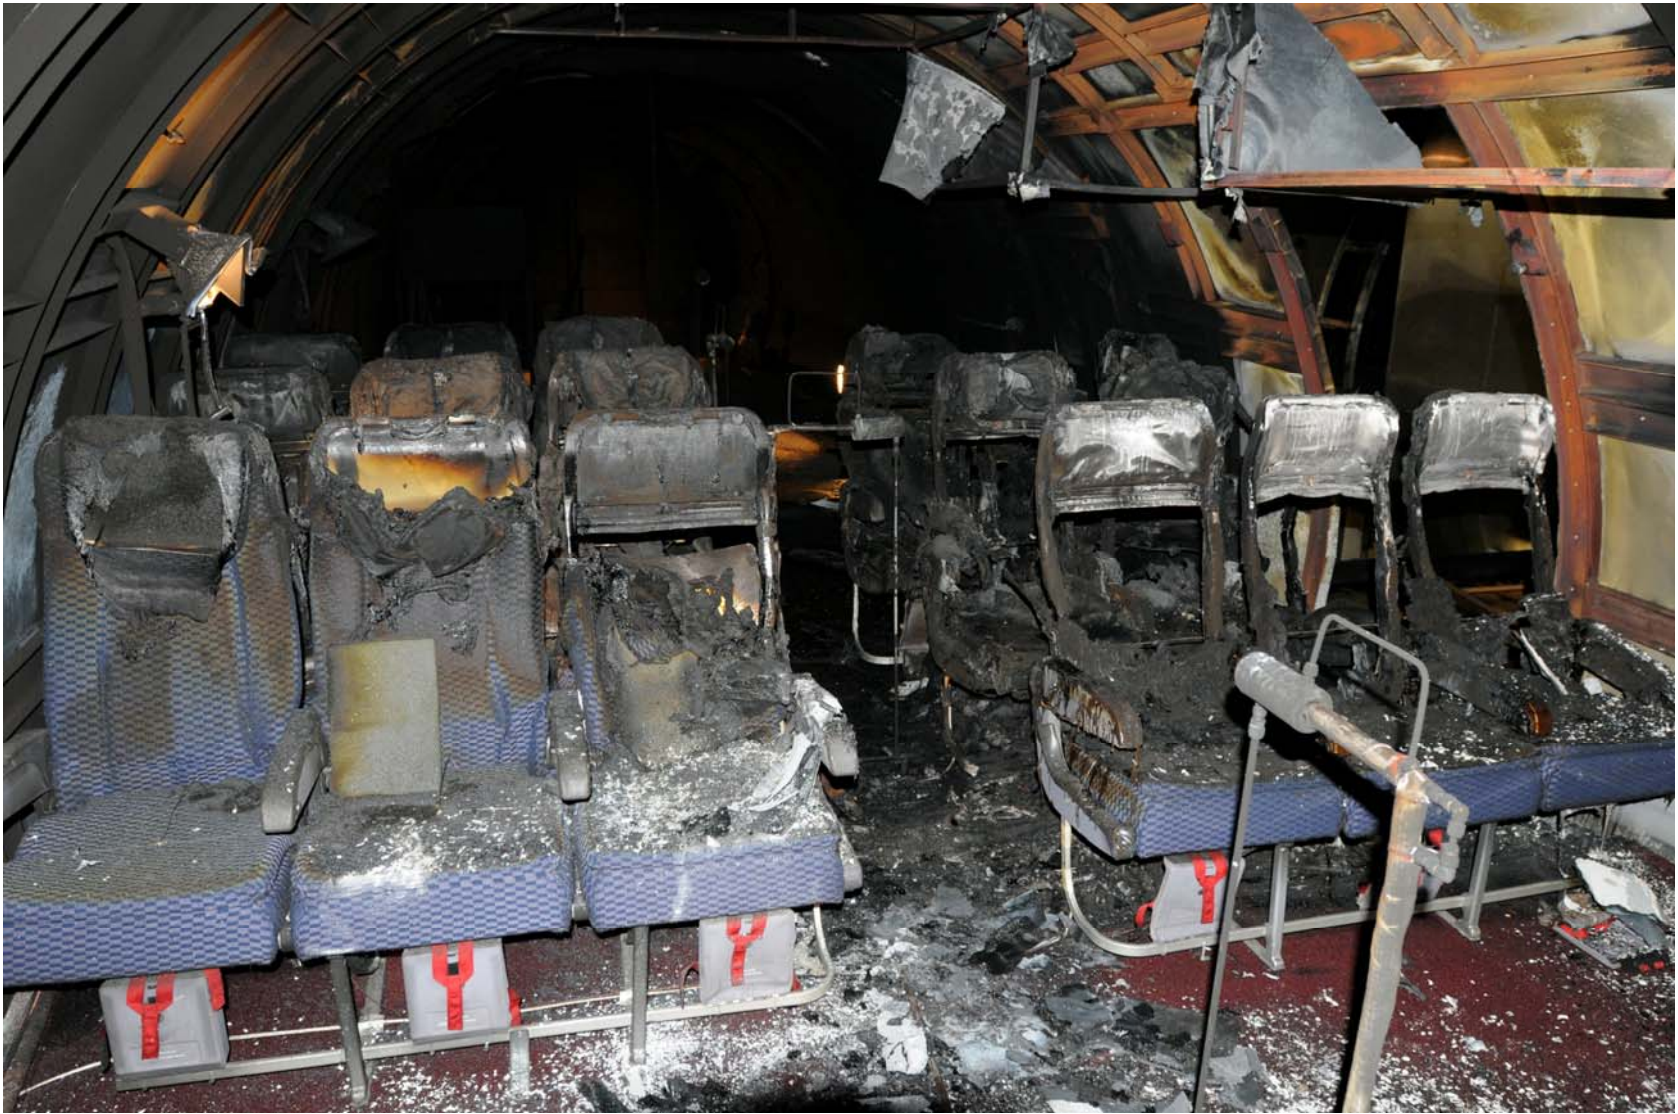
# Baseline 2 Test Results (panels removed)

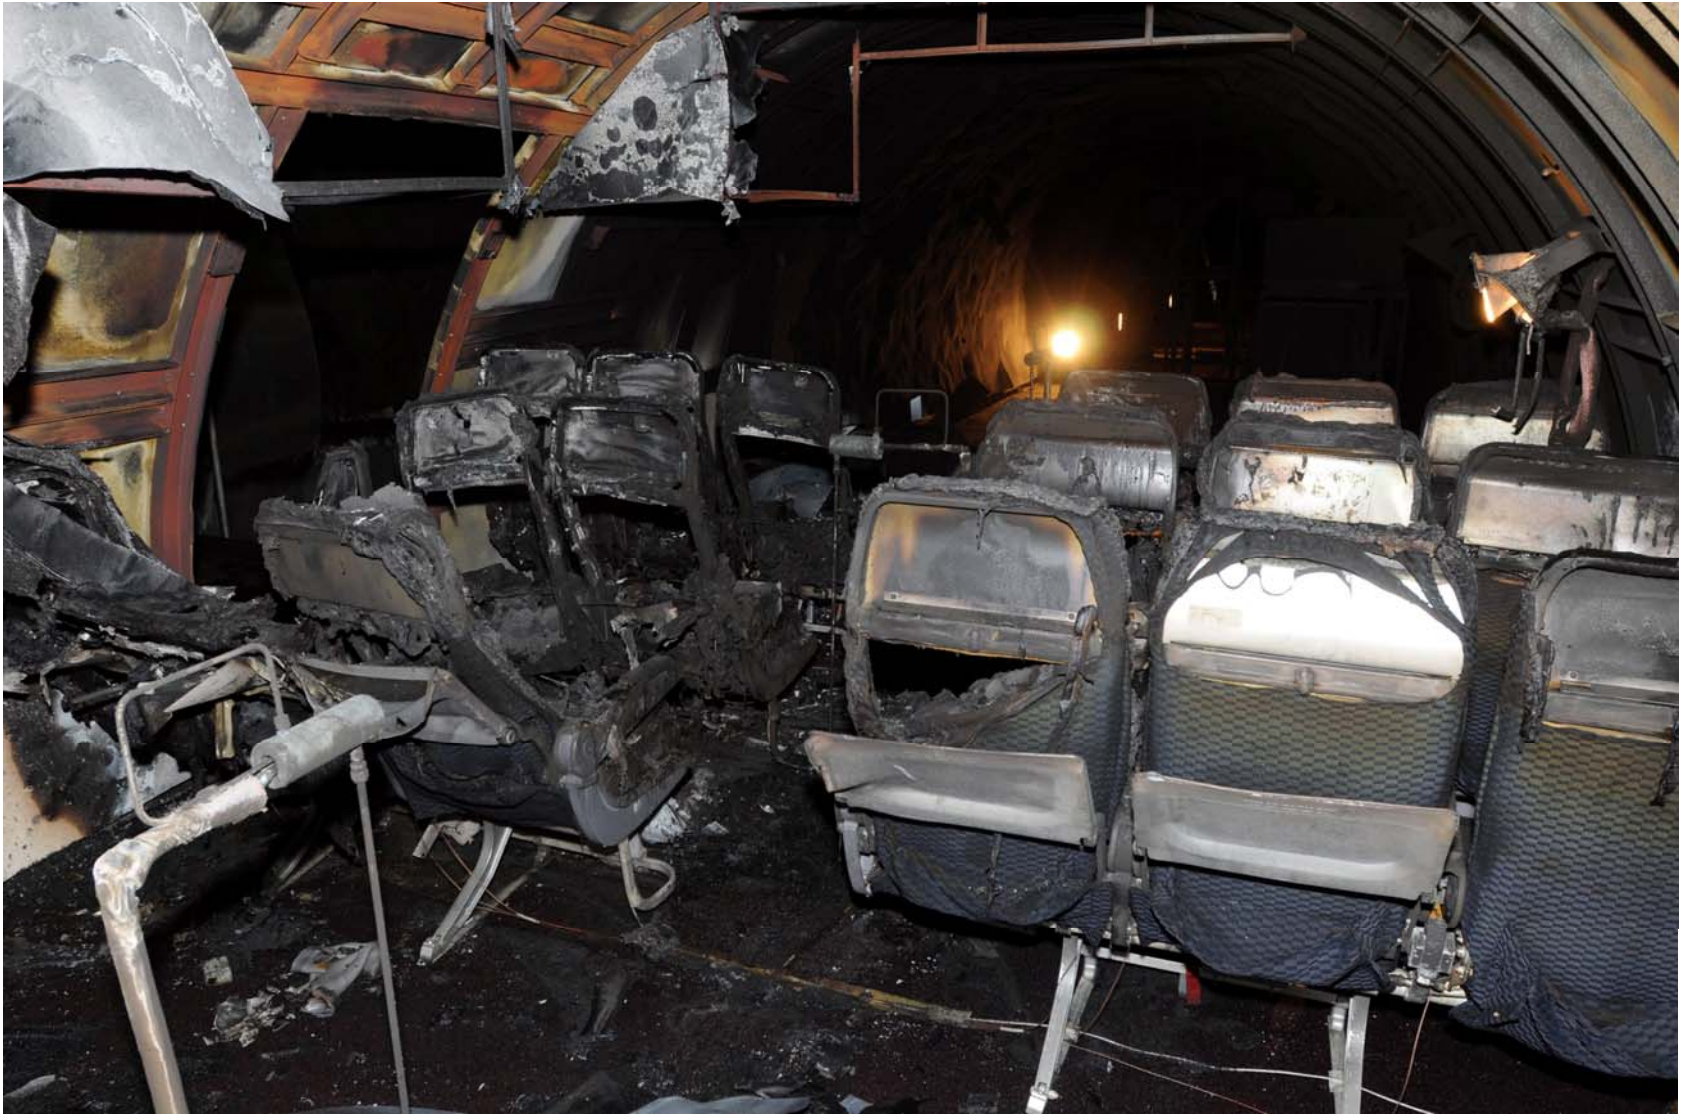
# Baseline 2 Test Results (panels removed)

What is the extent of damage to the primary components?

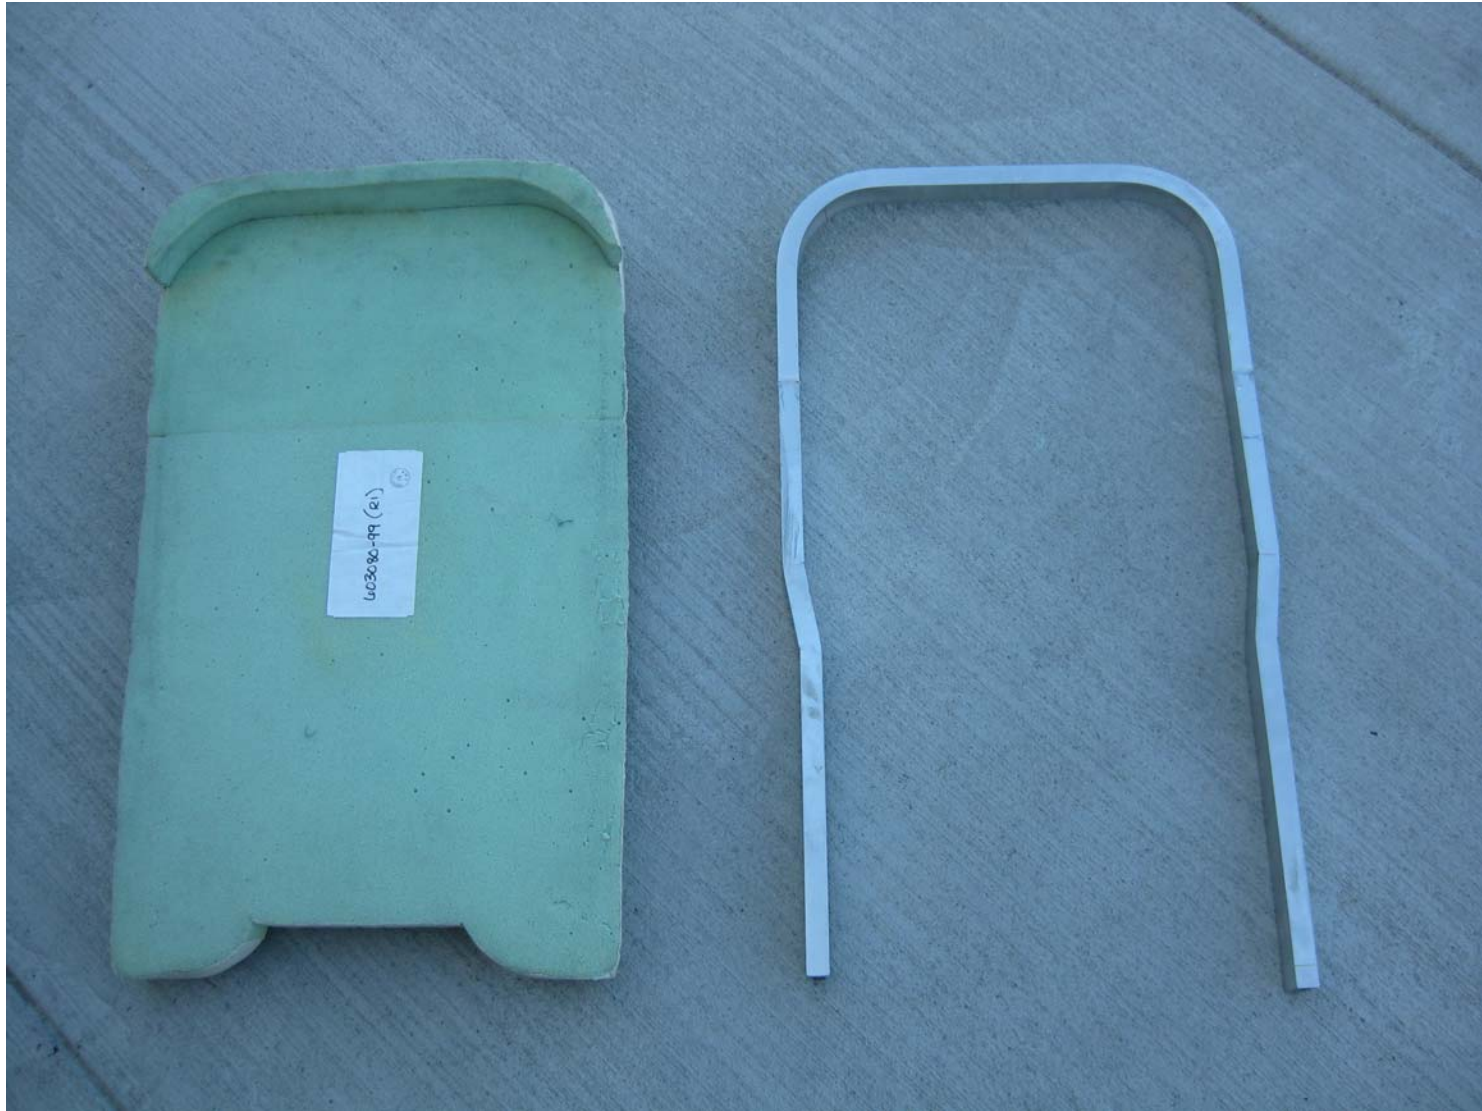
# New Fire Hardened Foam for Seat Frames

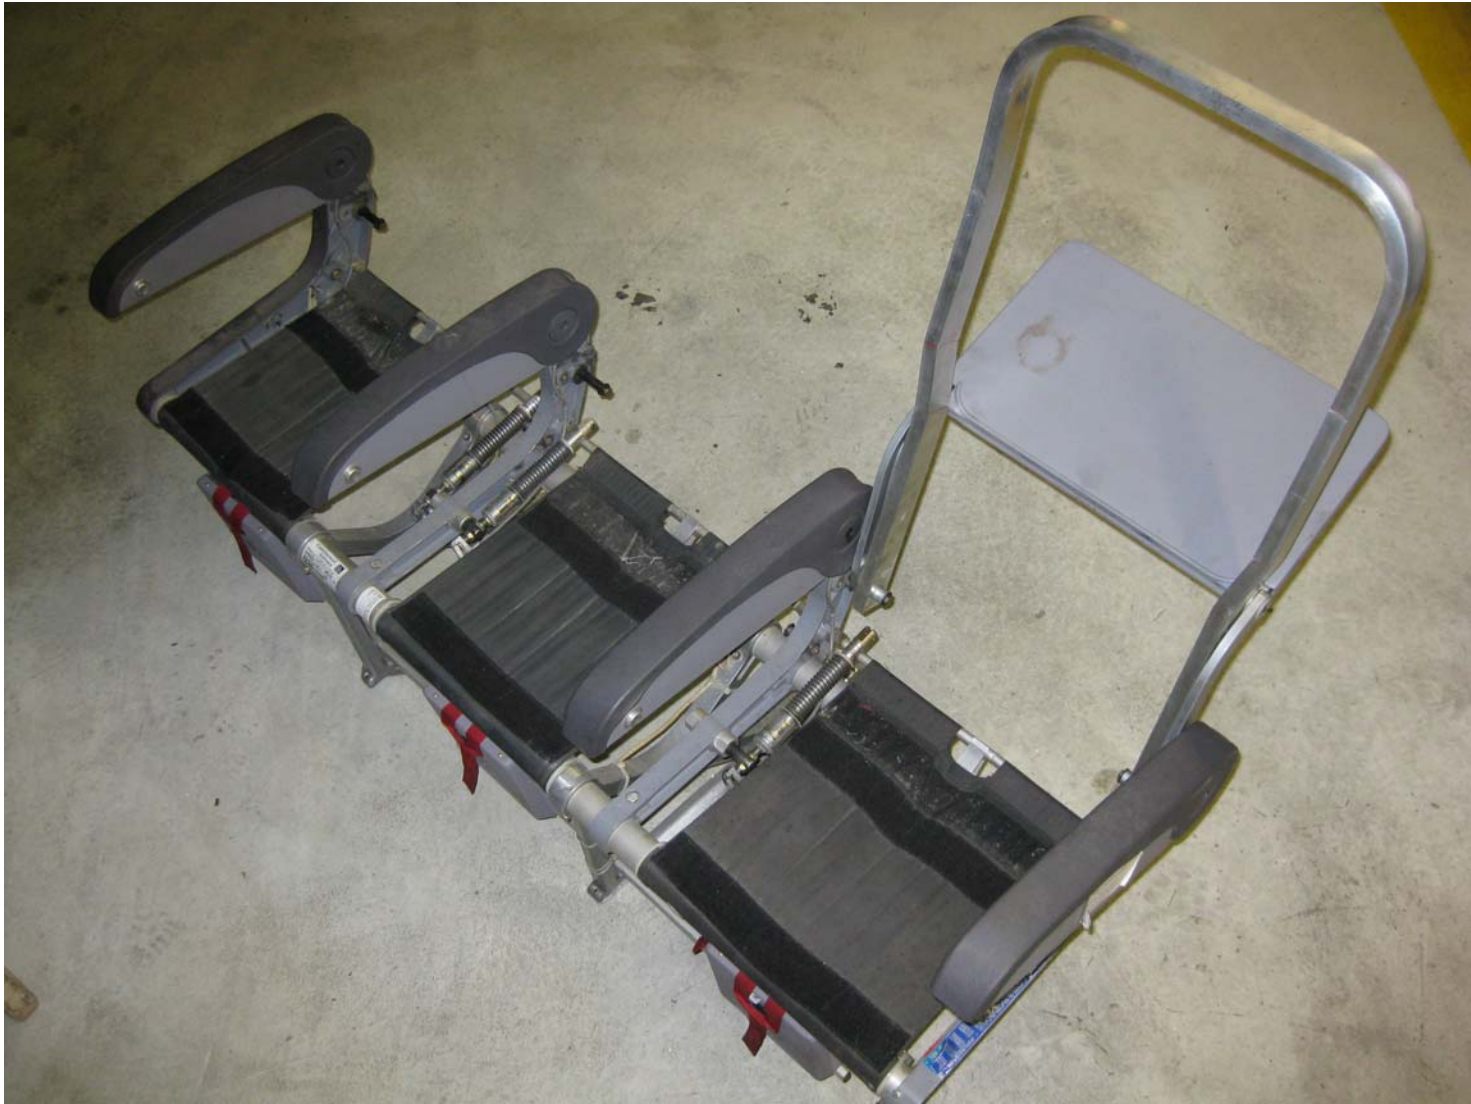
# New Back Frame Installed

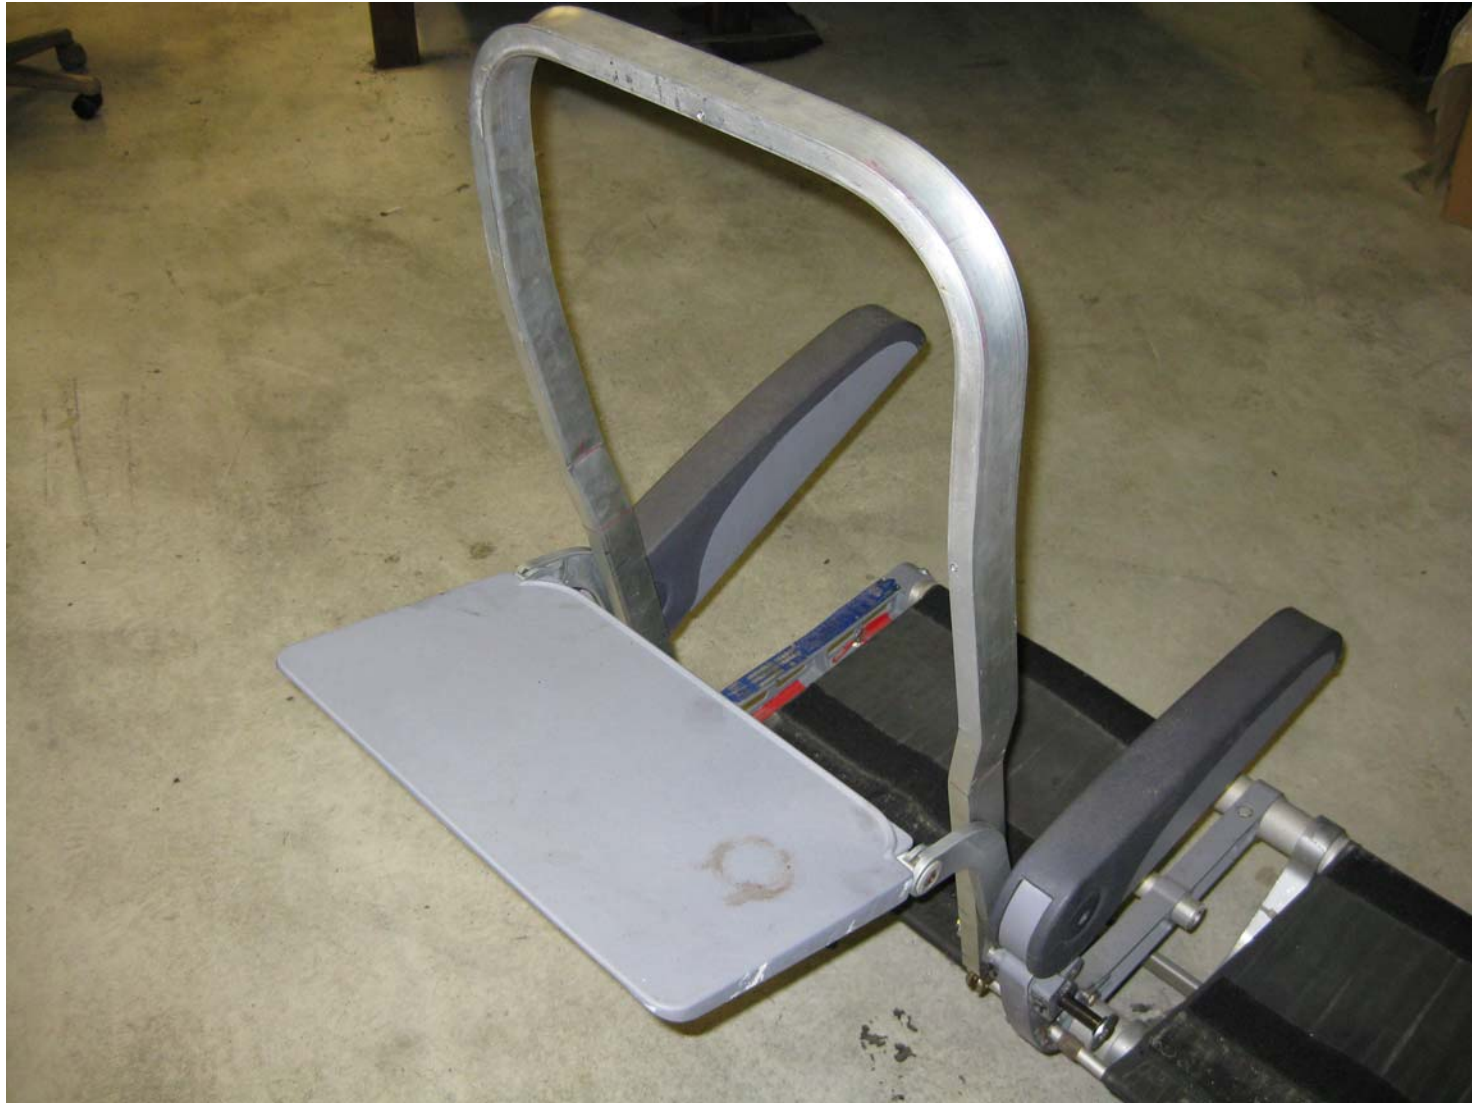
# Tray Table and Arms Attached to Frame

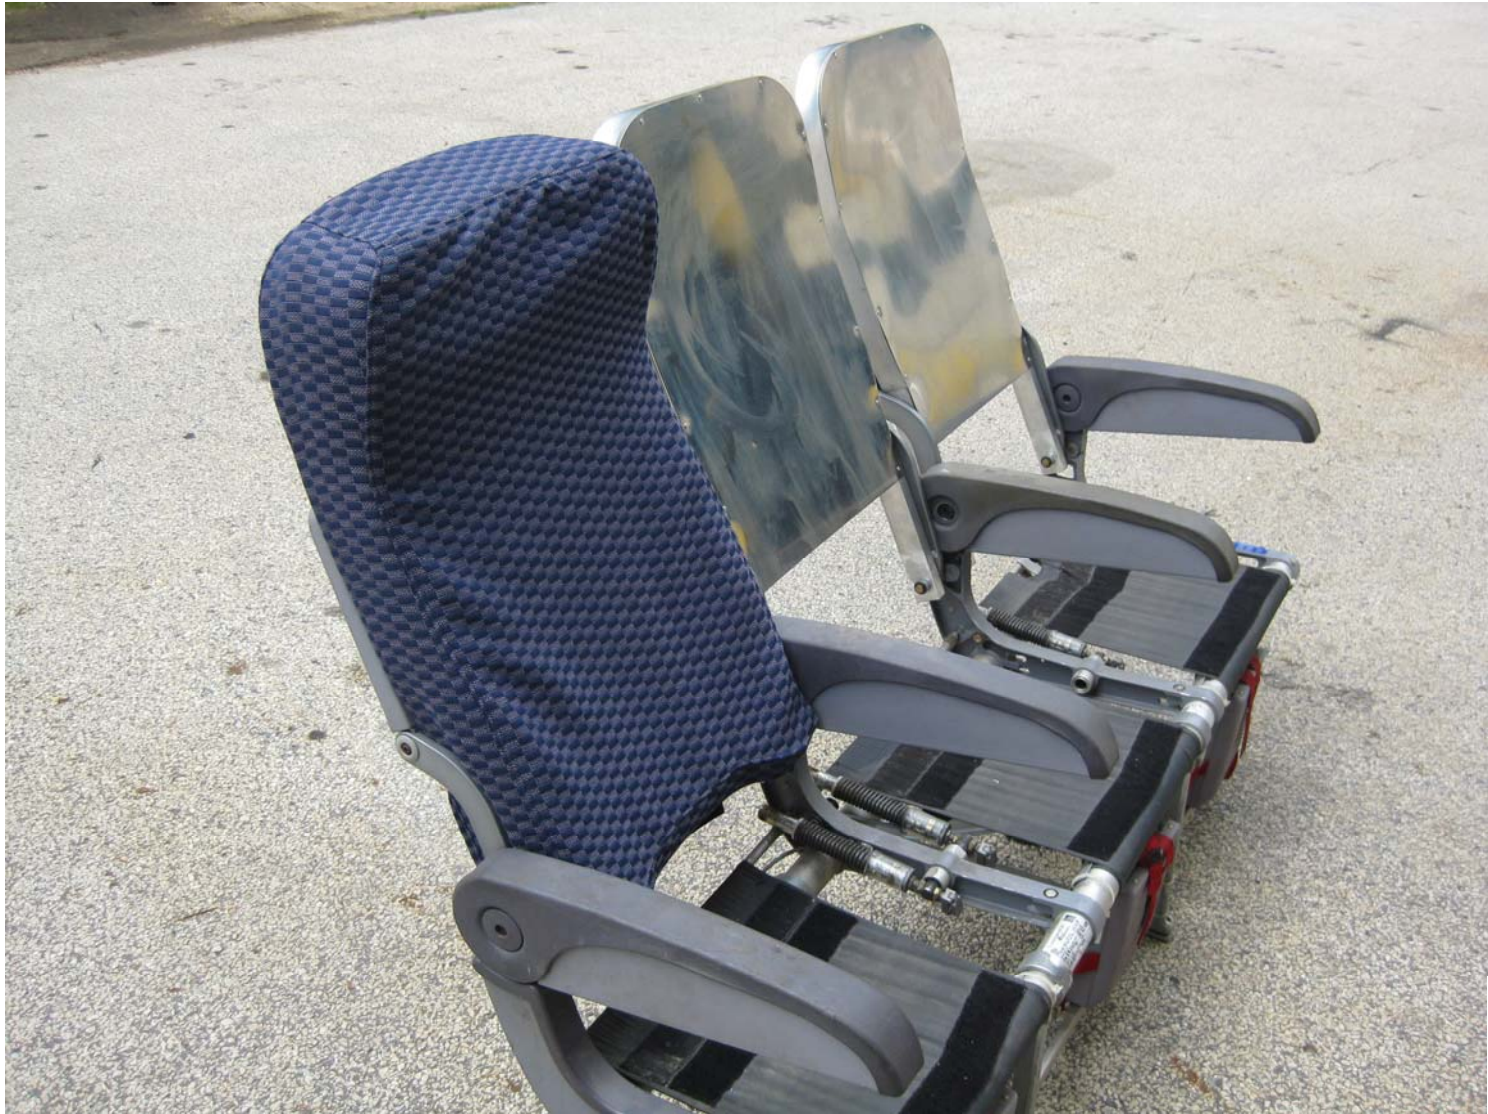
# Dress Cover Installed Over New Back Frame

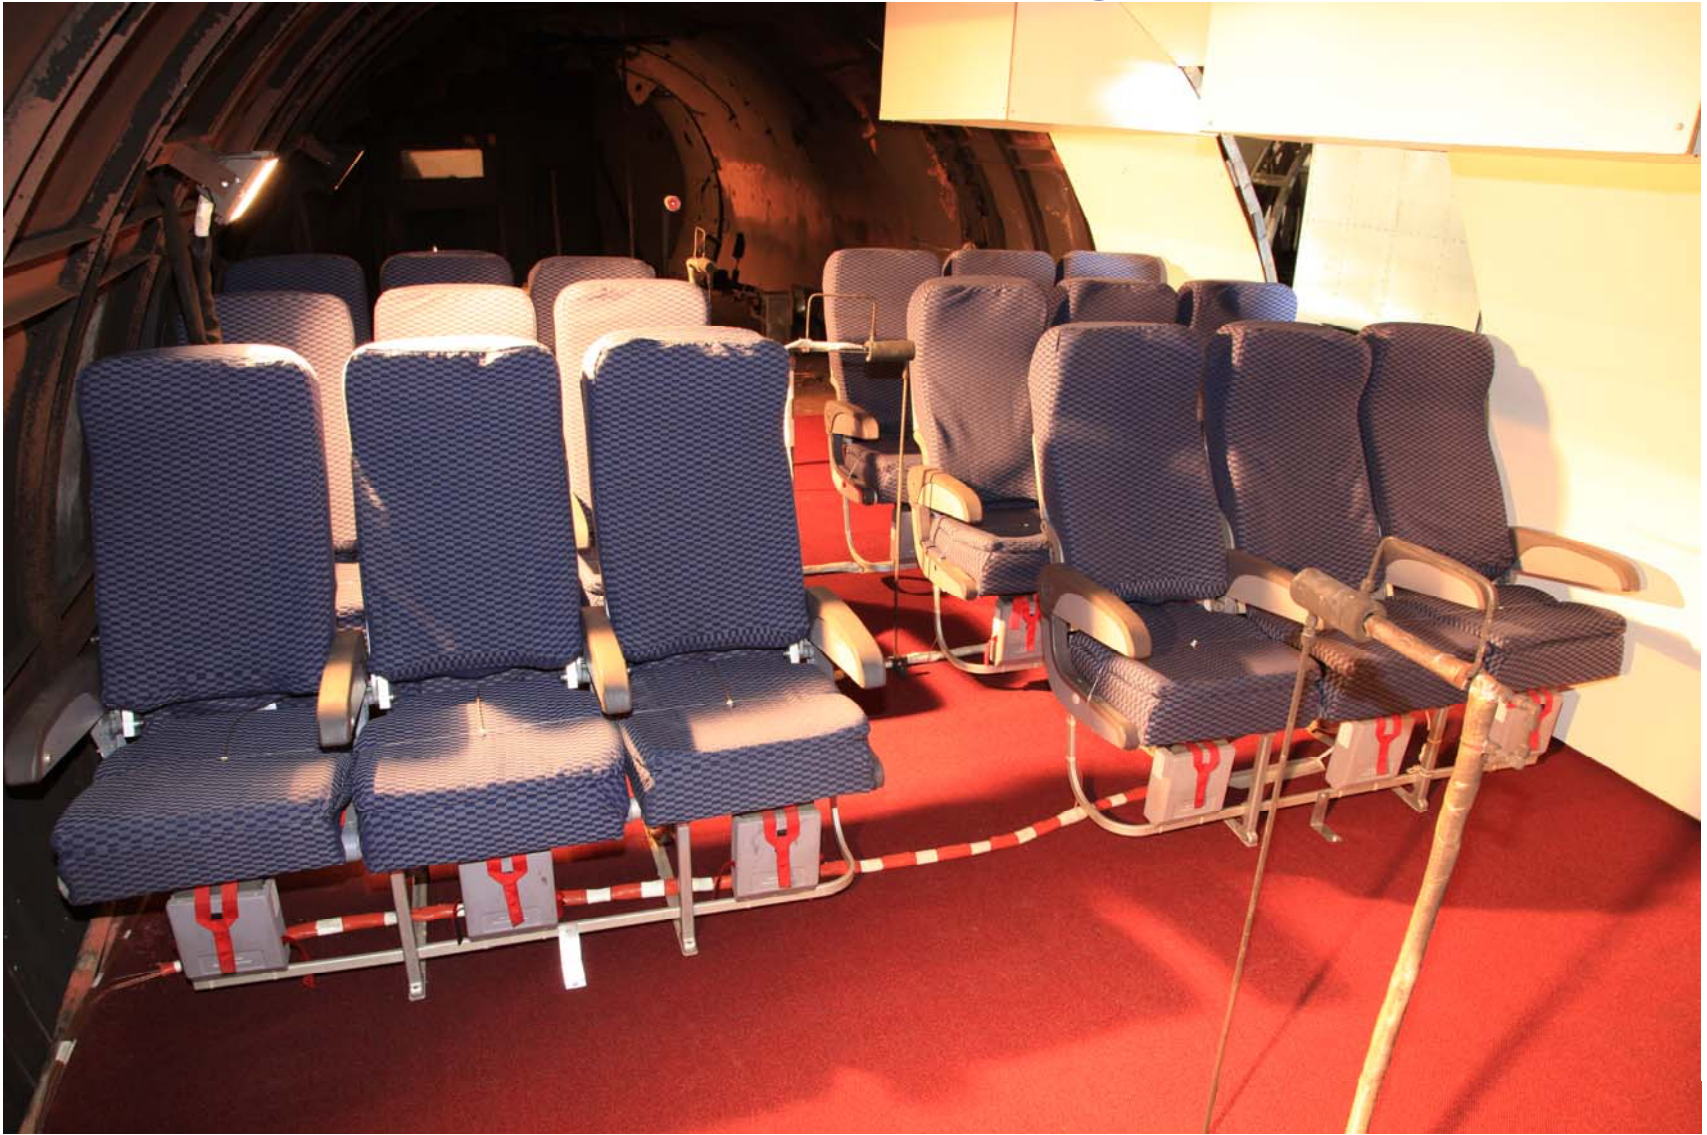
# Baseline 3 Test Configuration
