# International Aircraft Materials Fire Test Working Group

## Update on Flammability Testing of Magnesium Alloy Components

Date: October 21, 2009

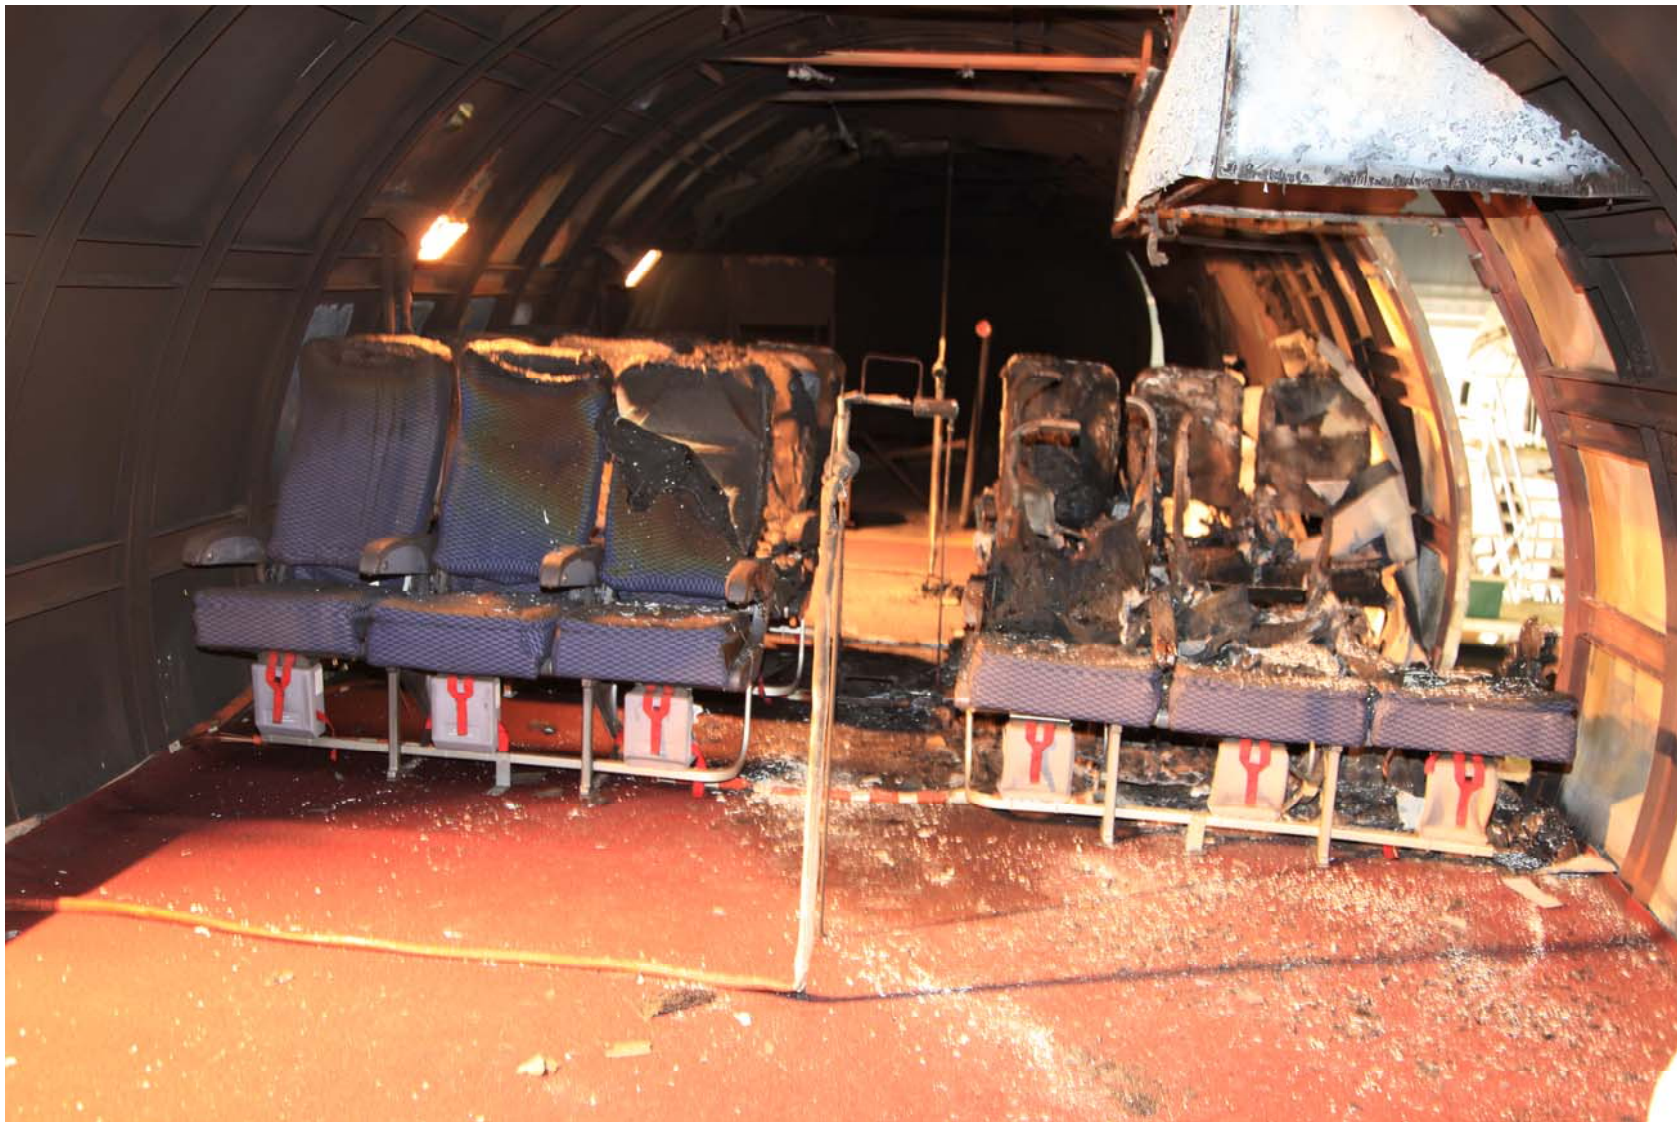
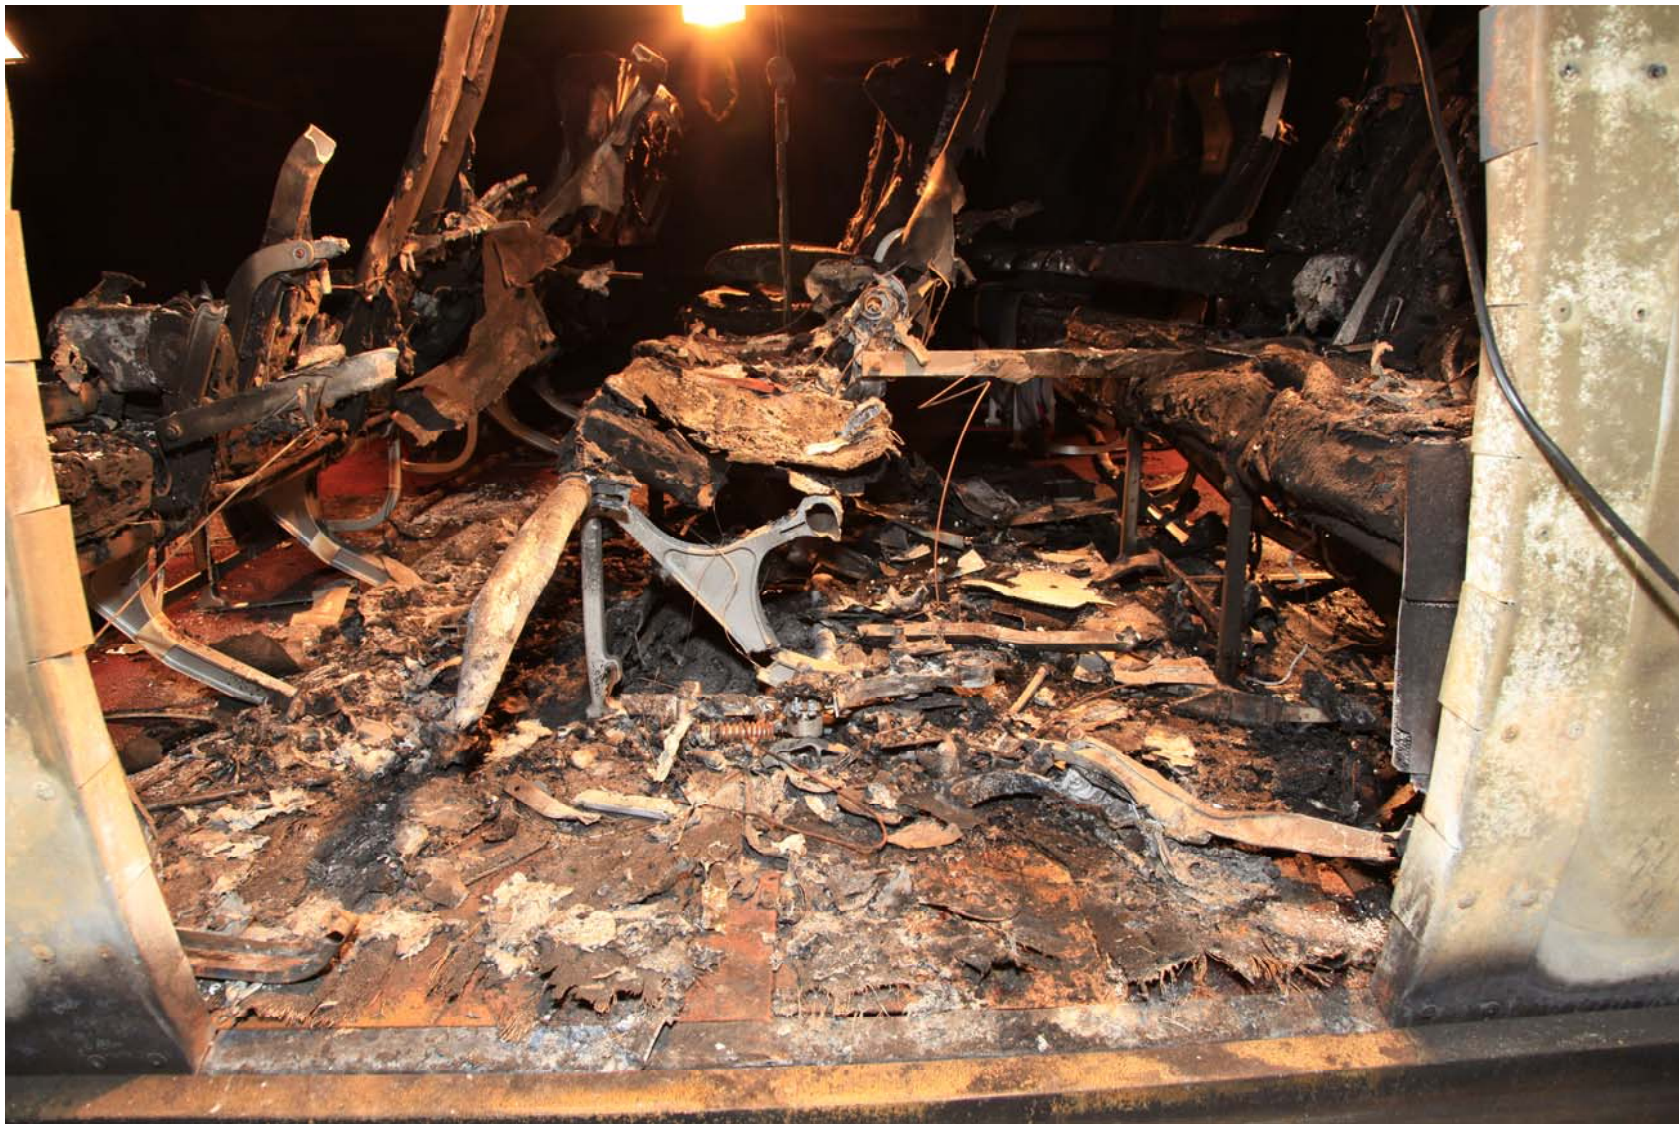
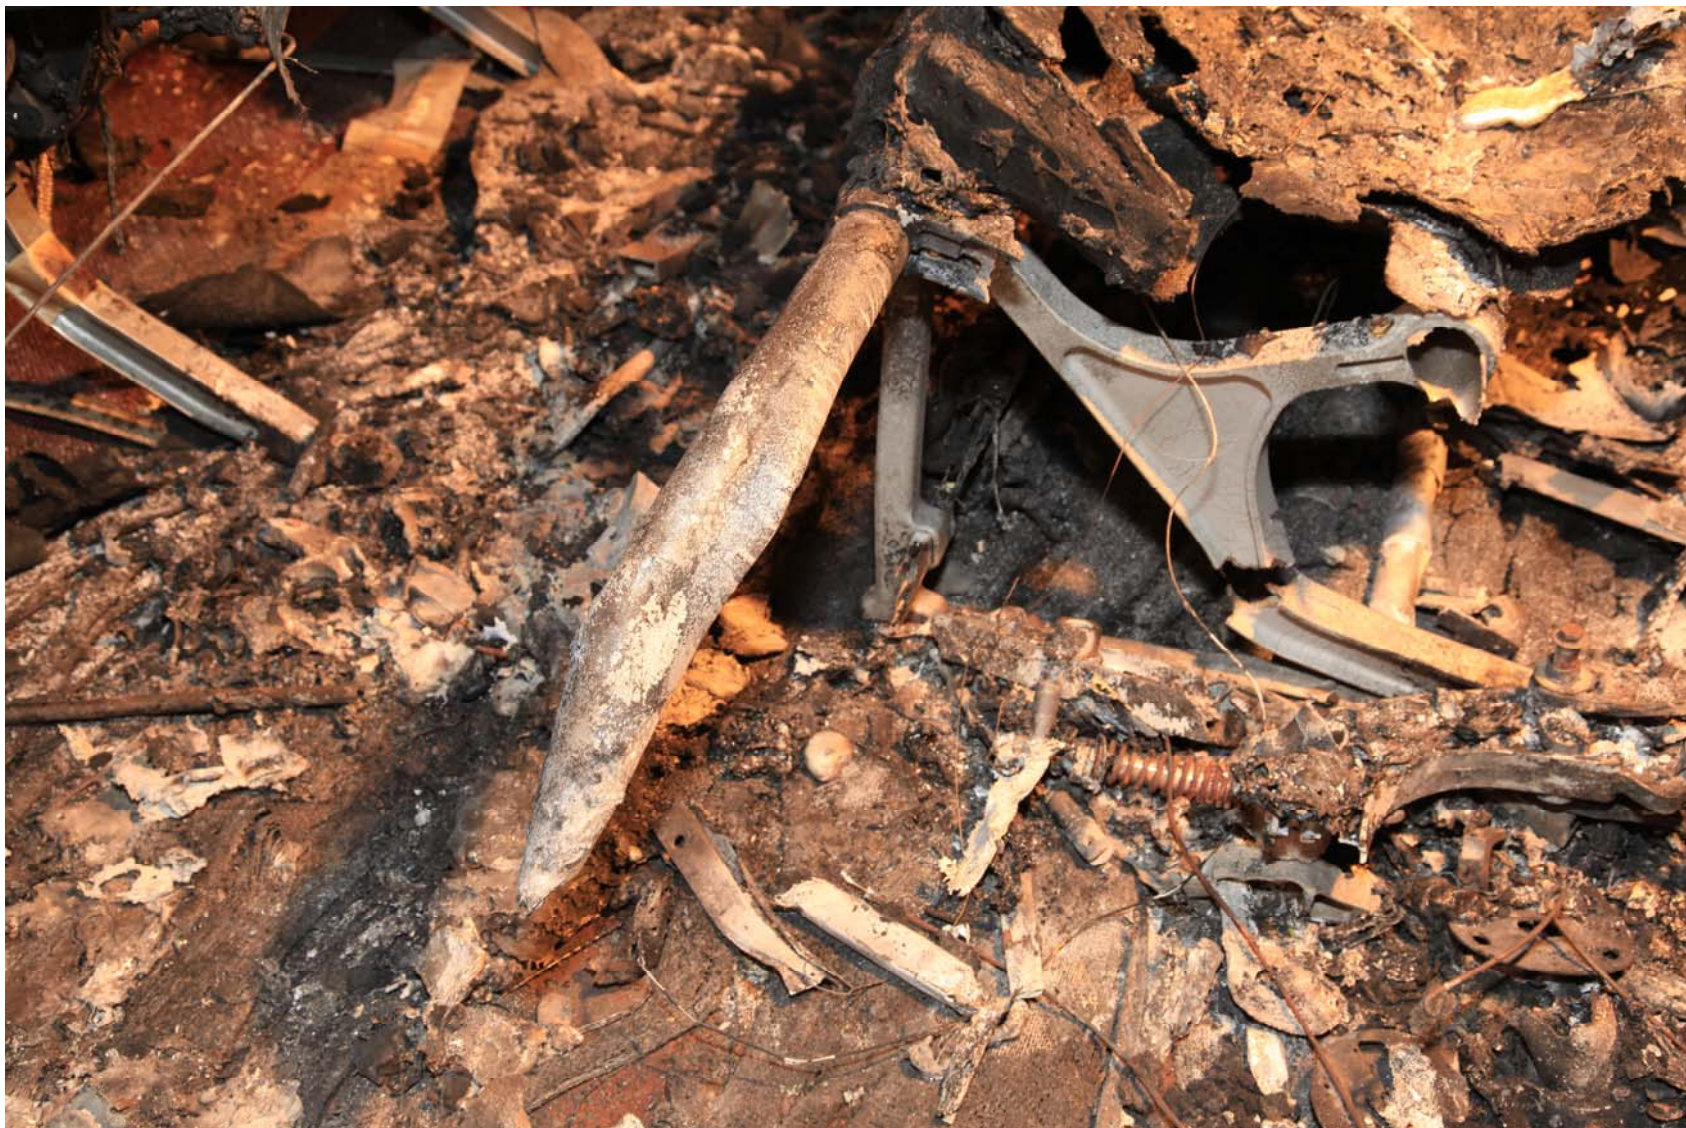
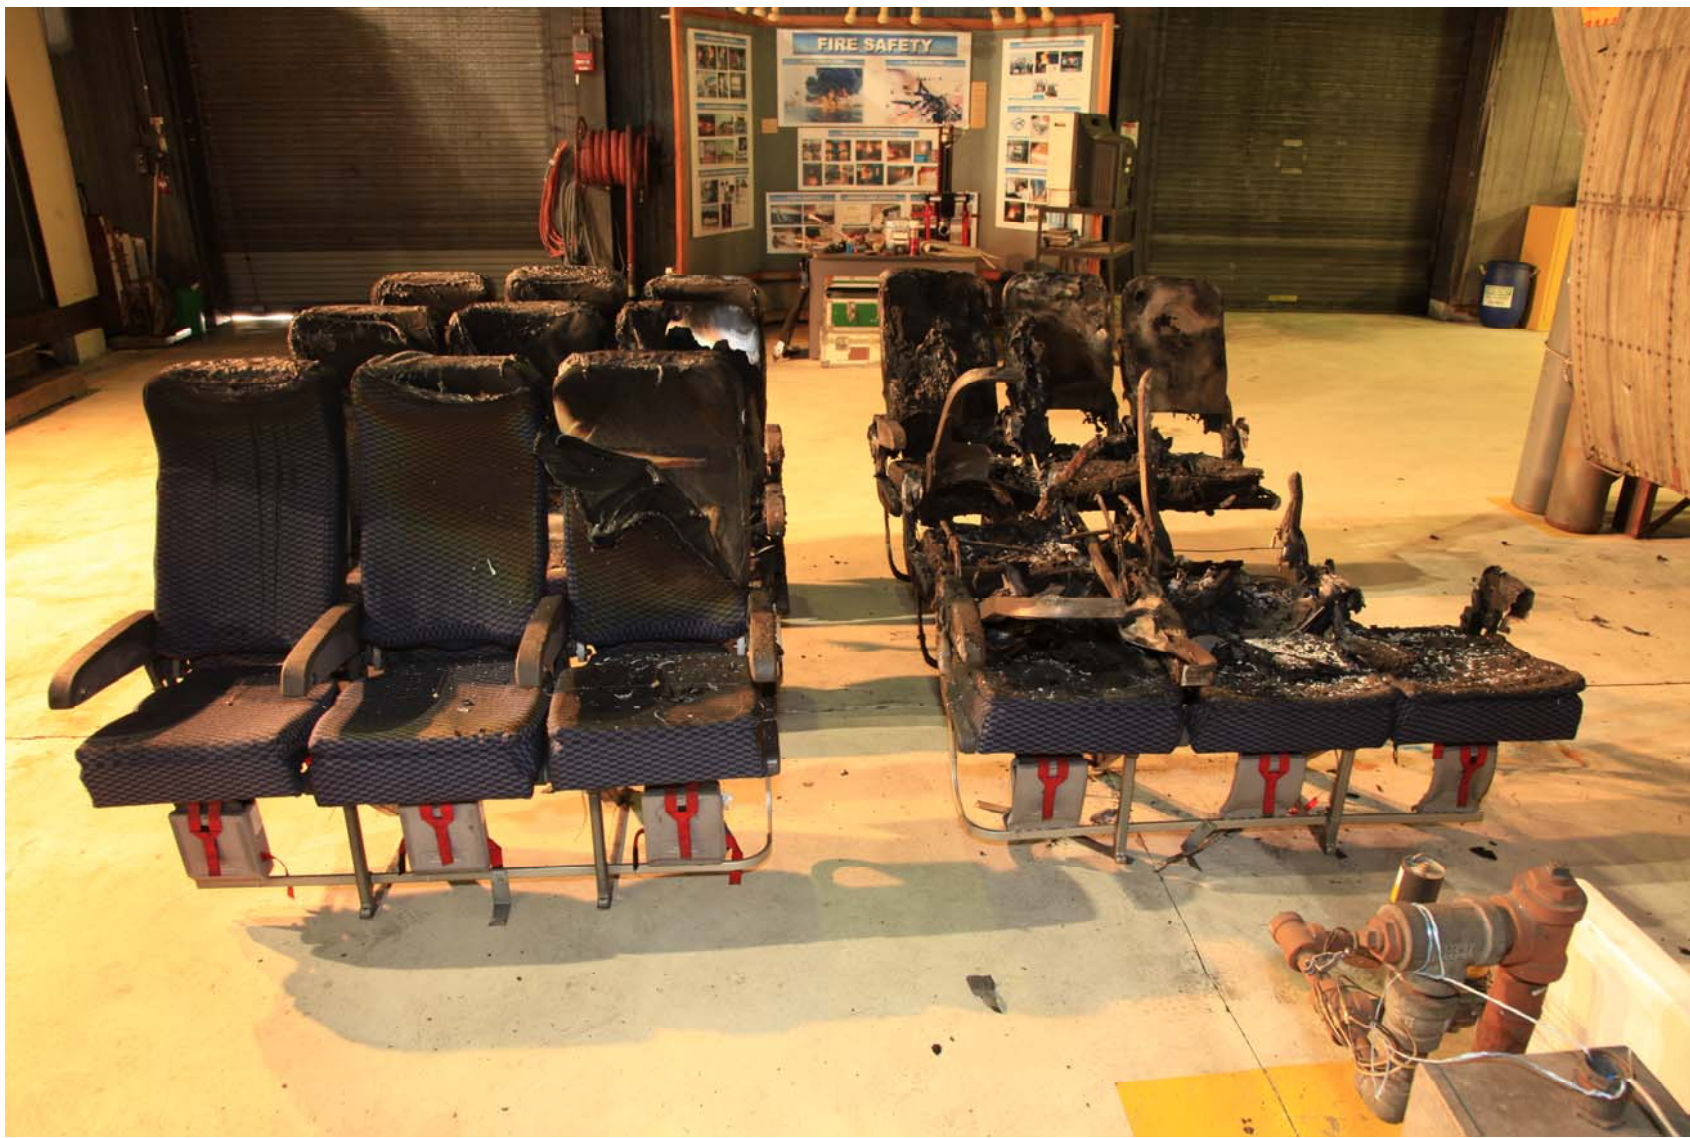
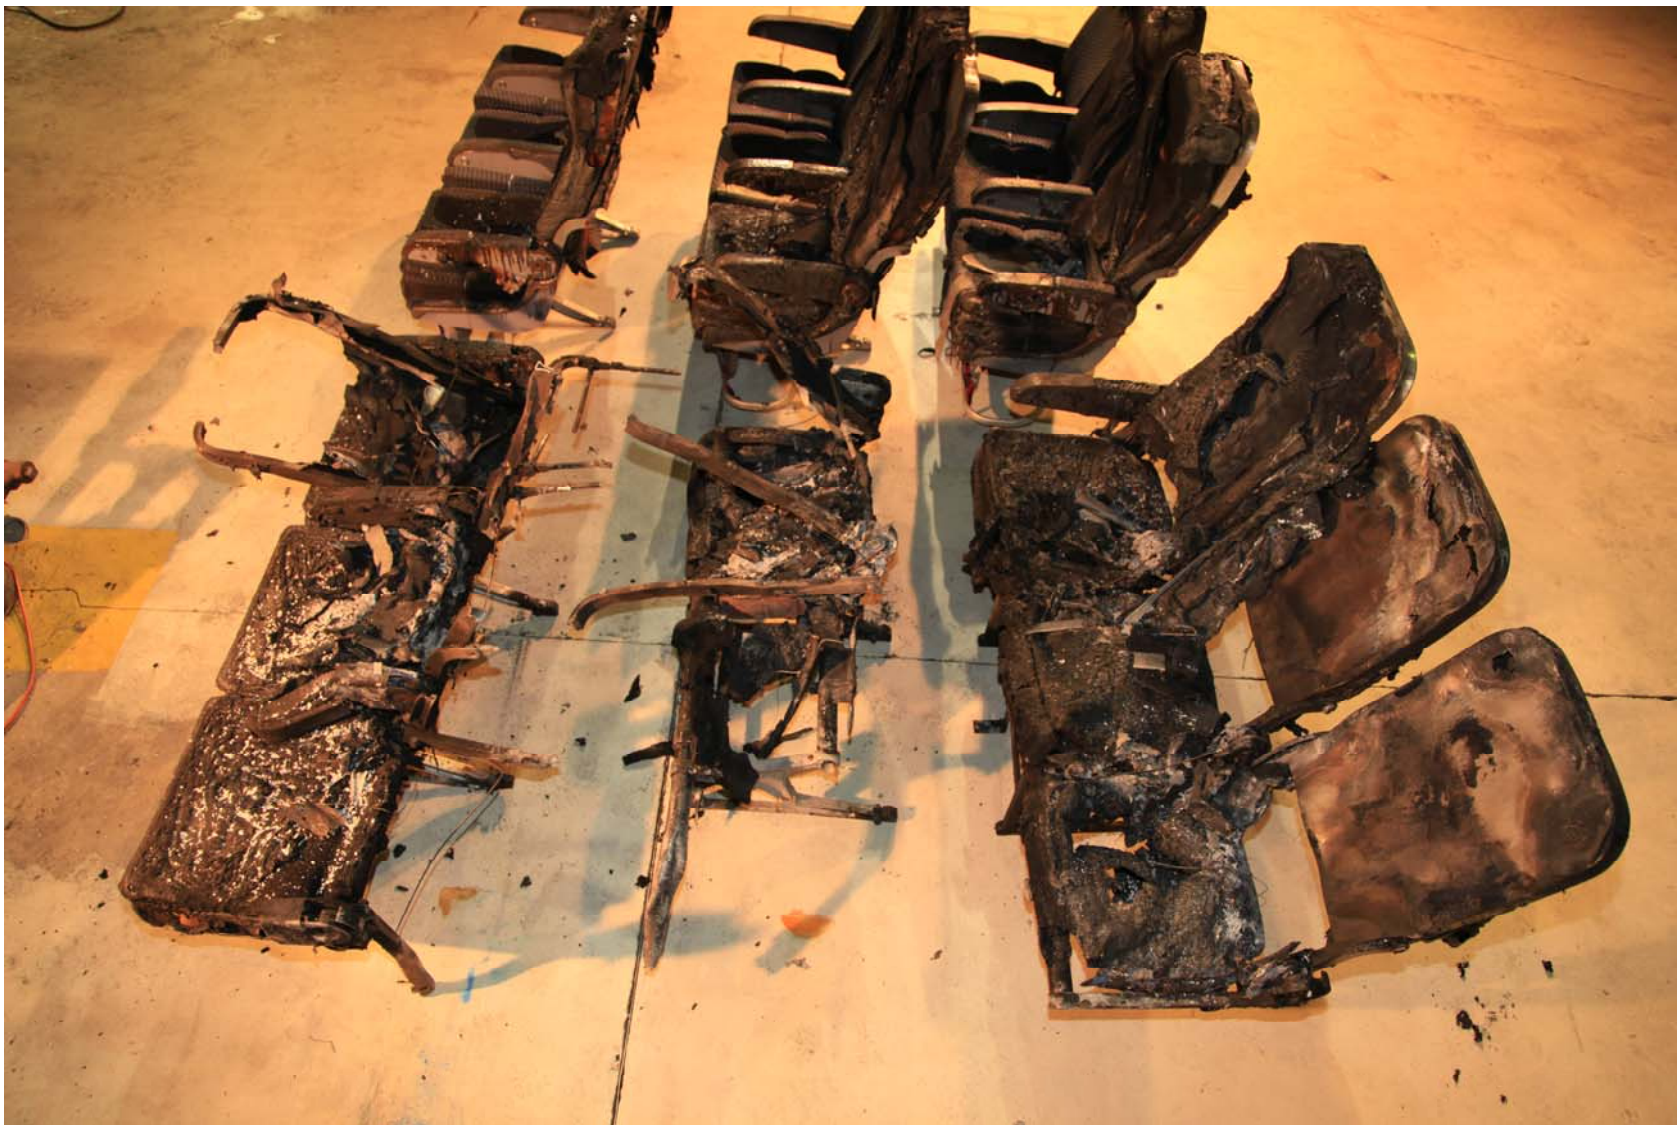
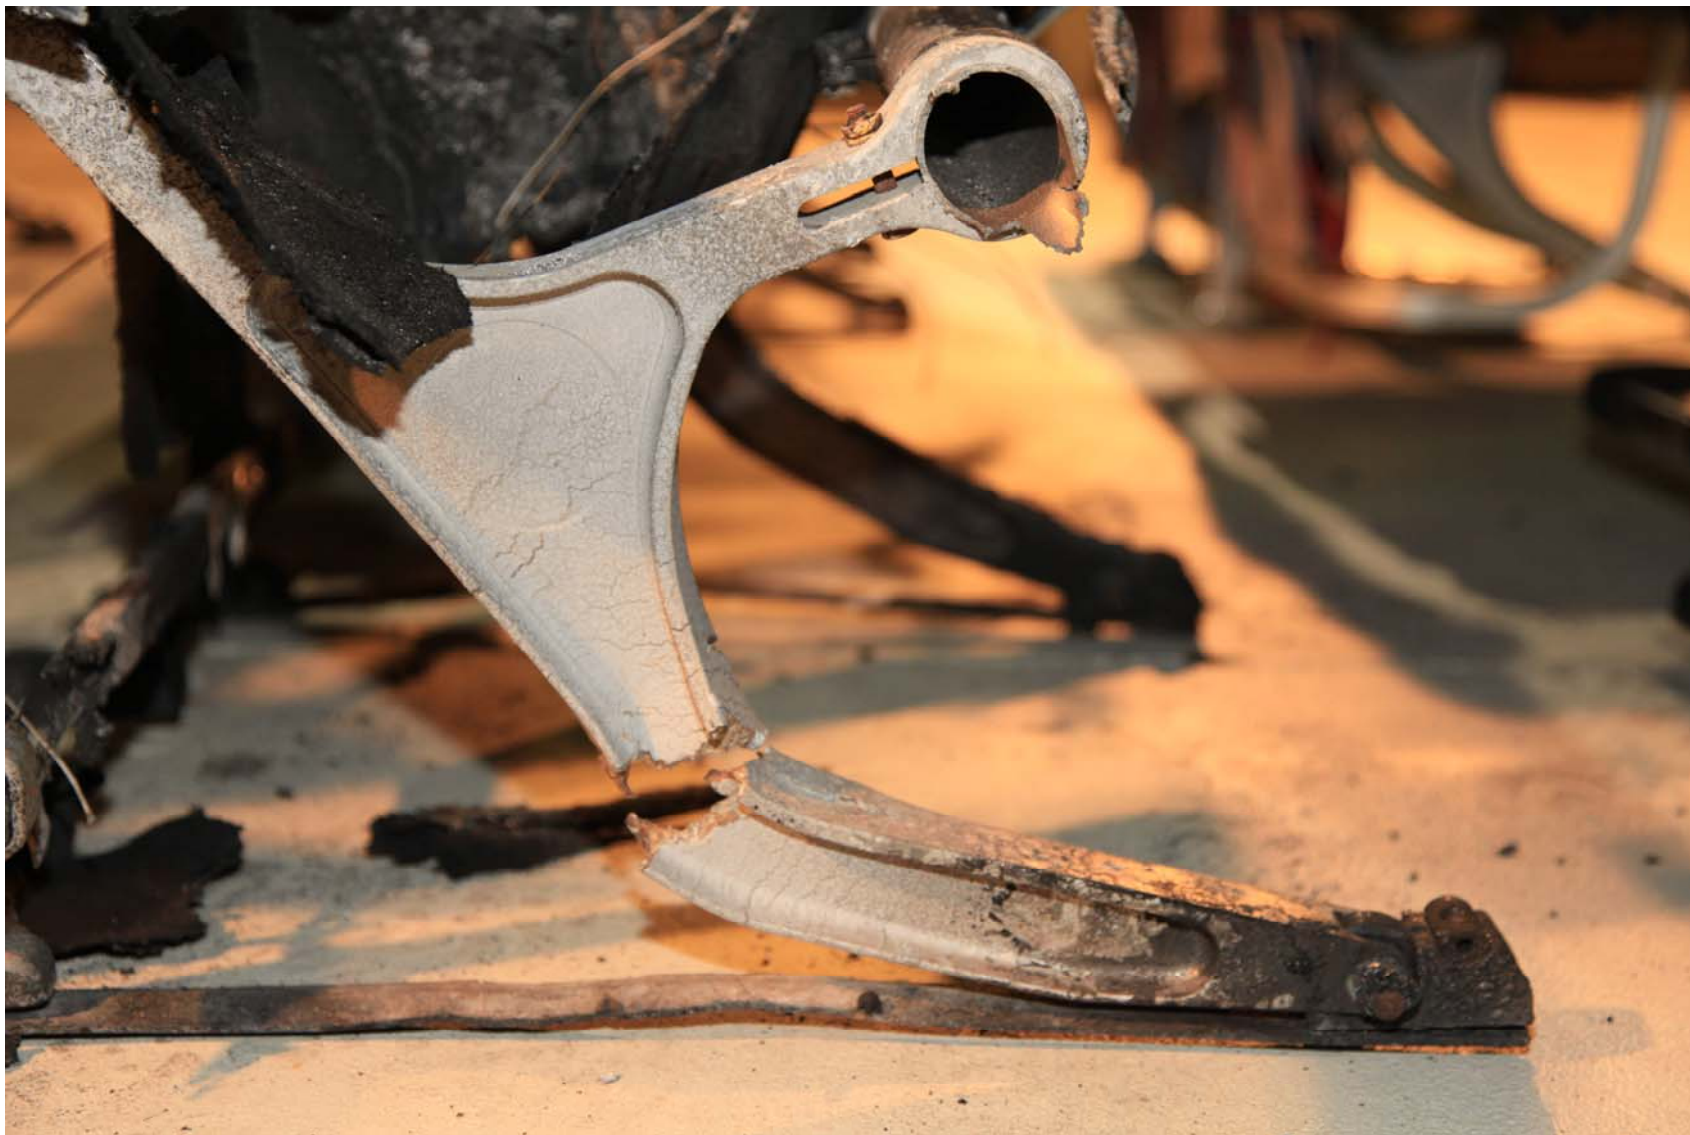
# Baseline 3 Test Results

Pan fire extinguished at 5 minutes using AFFF

Interior fire extinguished at 10 minutes using water

Incapacitation reached in 4 min 31 sec at forward location

Seat backs (cushions, covers, plastics) mostly consumed on port side; largely intact on starboard side

Seat bottom cushions on port side heavily involved in fire

Increased melting of primary seat structure compared to previous baseline tests

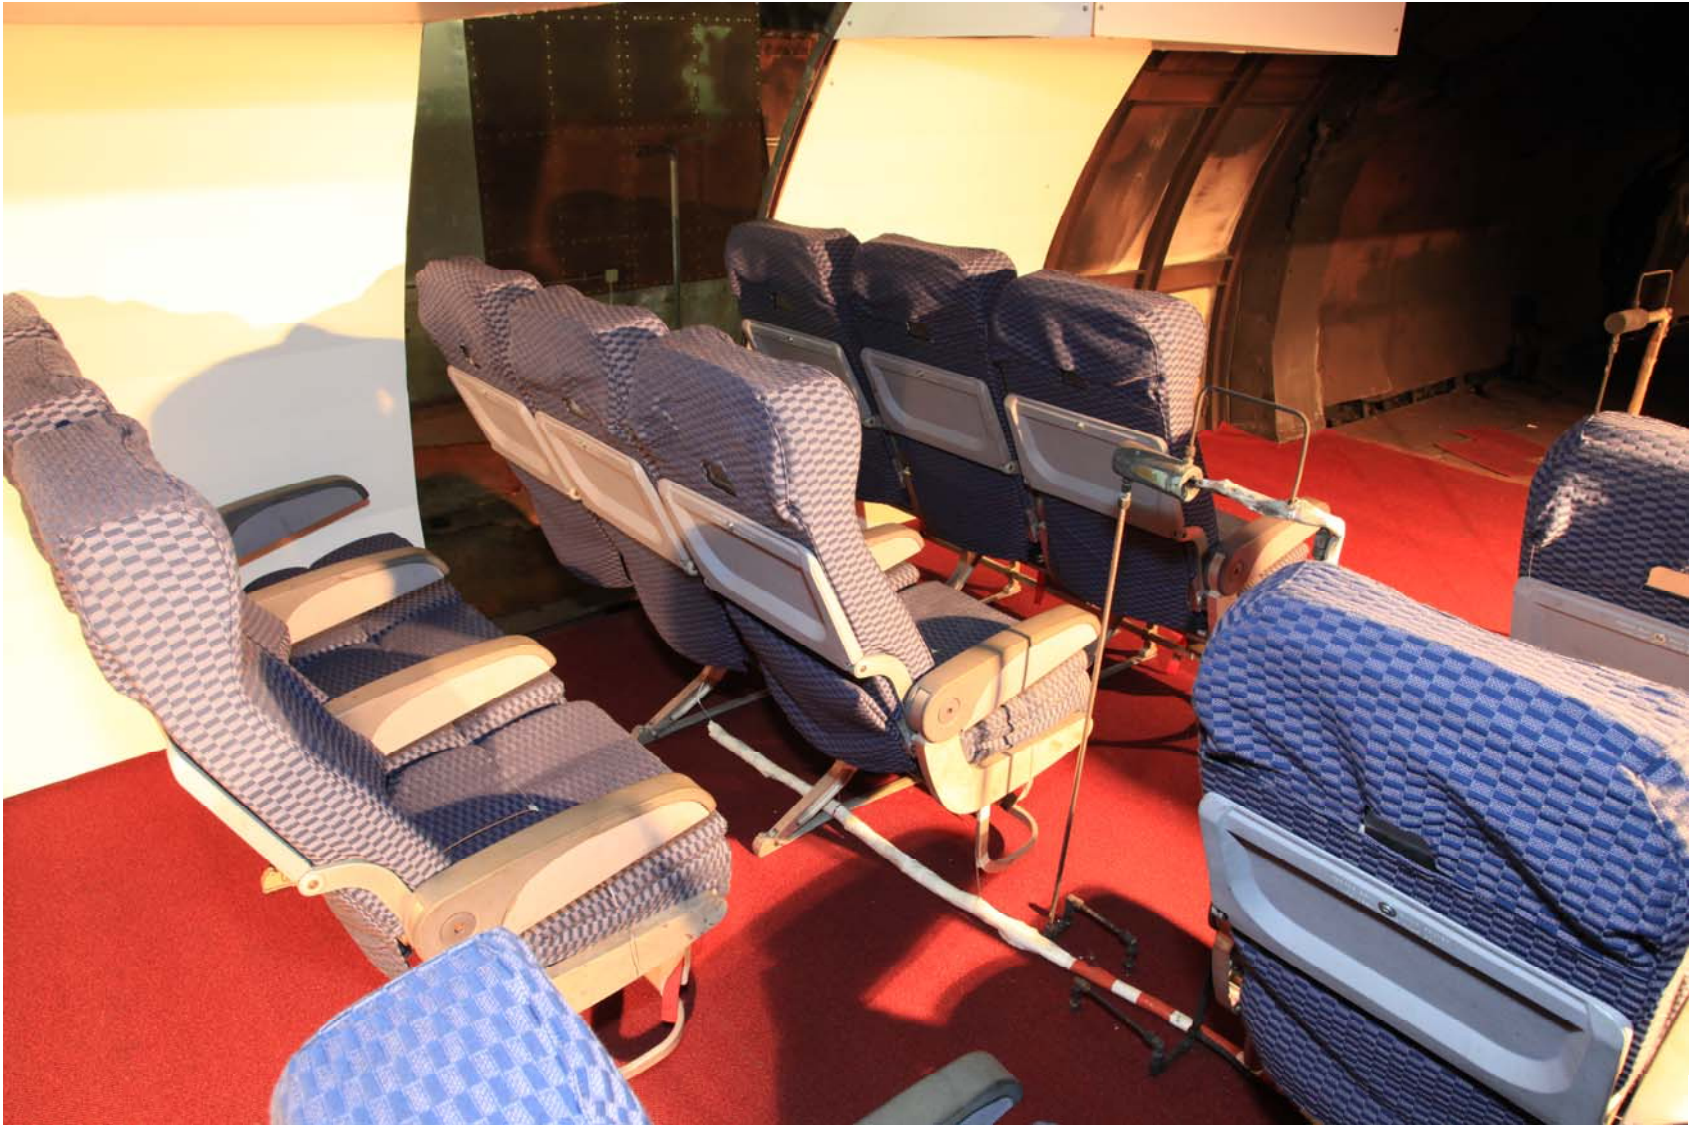
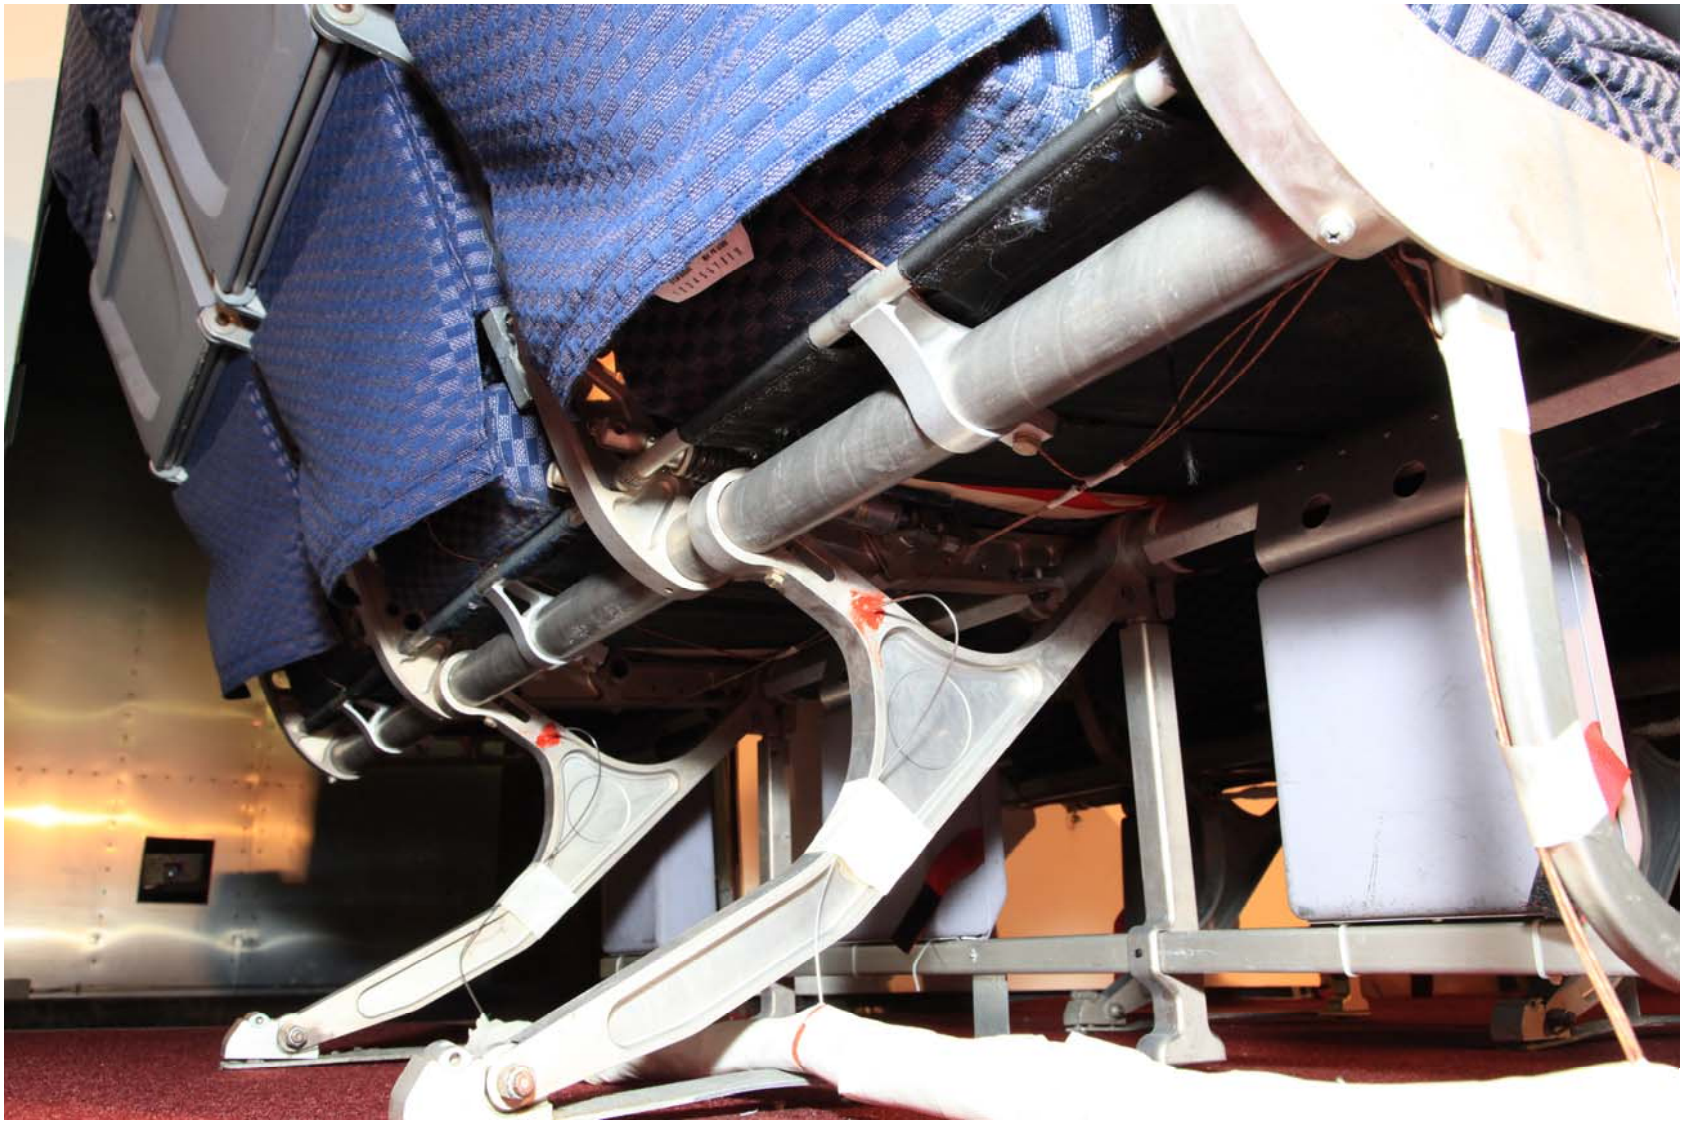
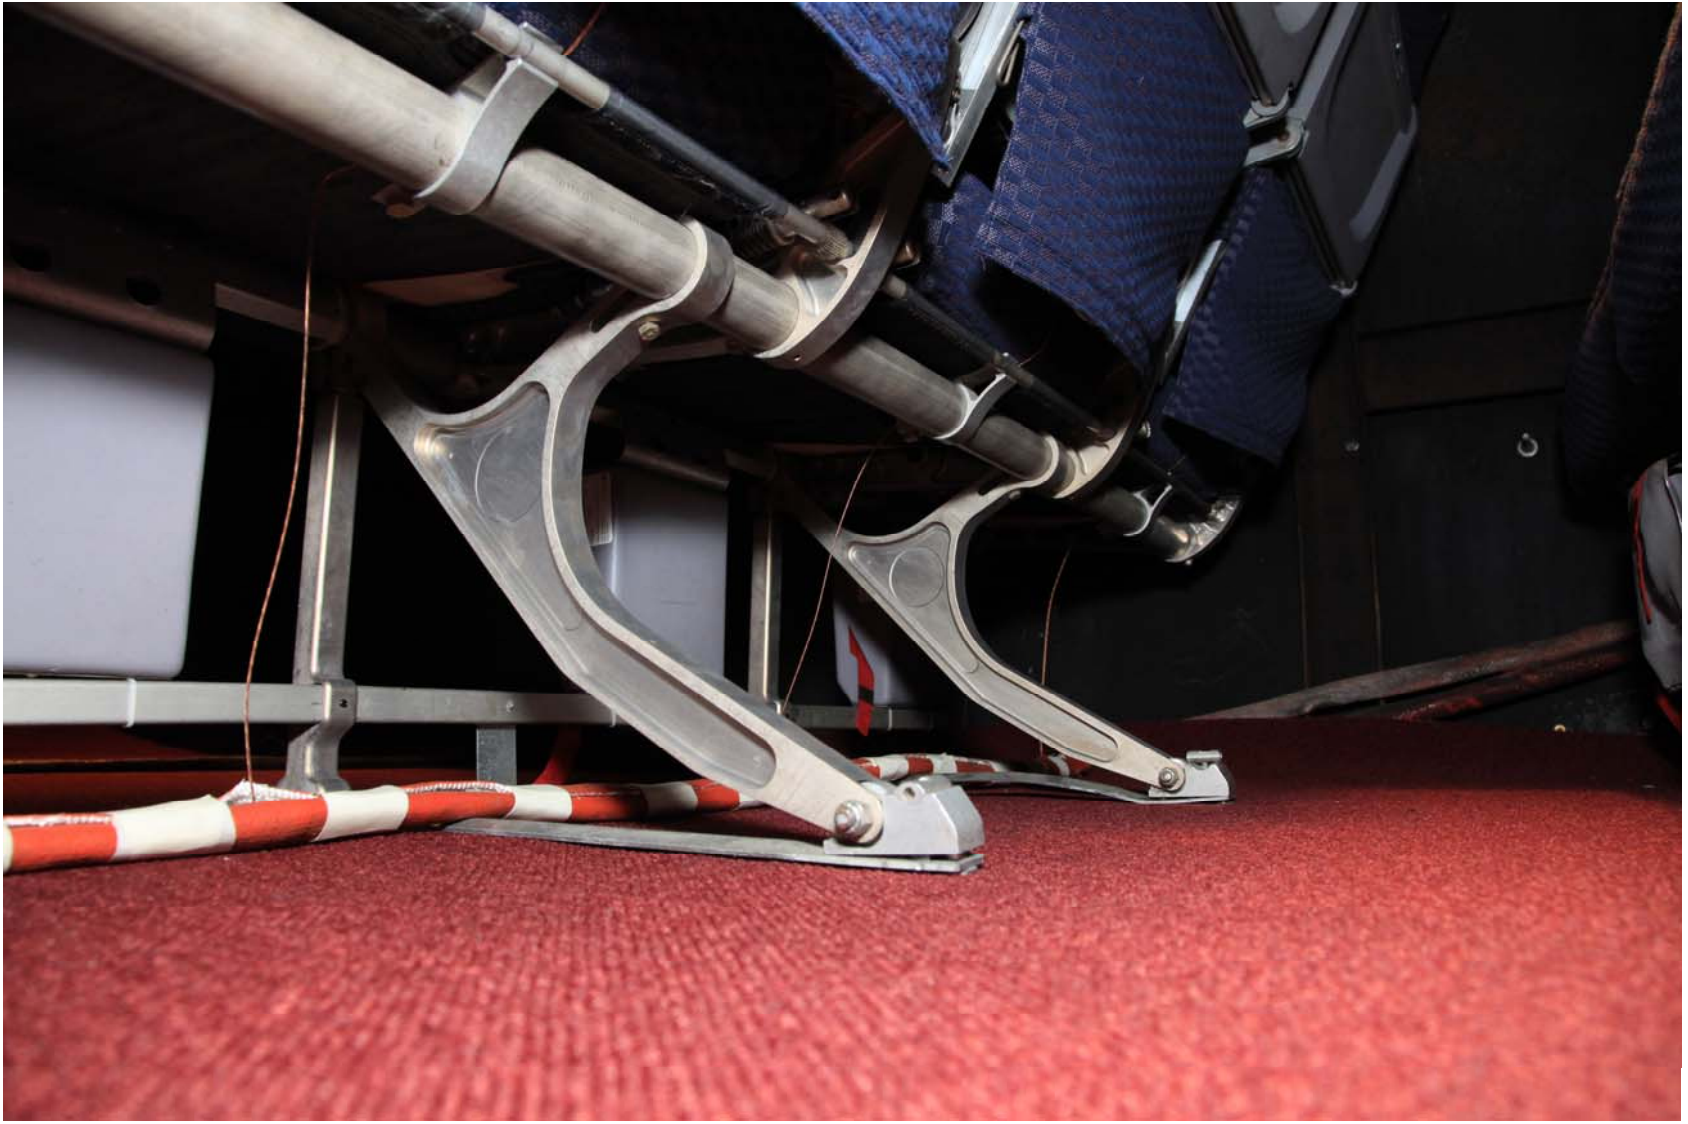
# WE-43 Test Configuration
