# International Aircraft Materials Fire Test Working Group

## Update on Flammability Testing of Magnesium Alloy Components

Date: October 21, 2009

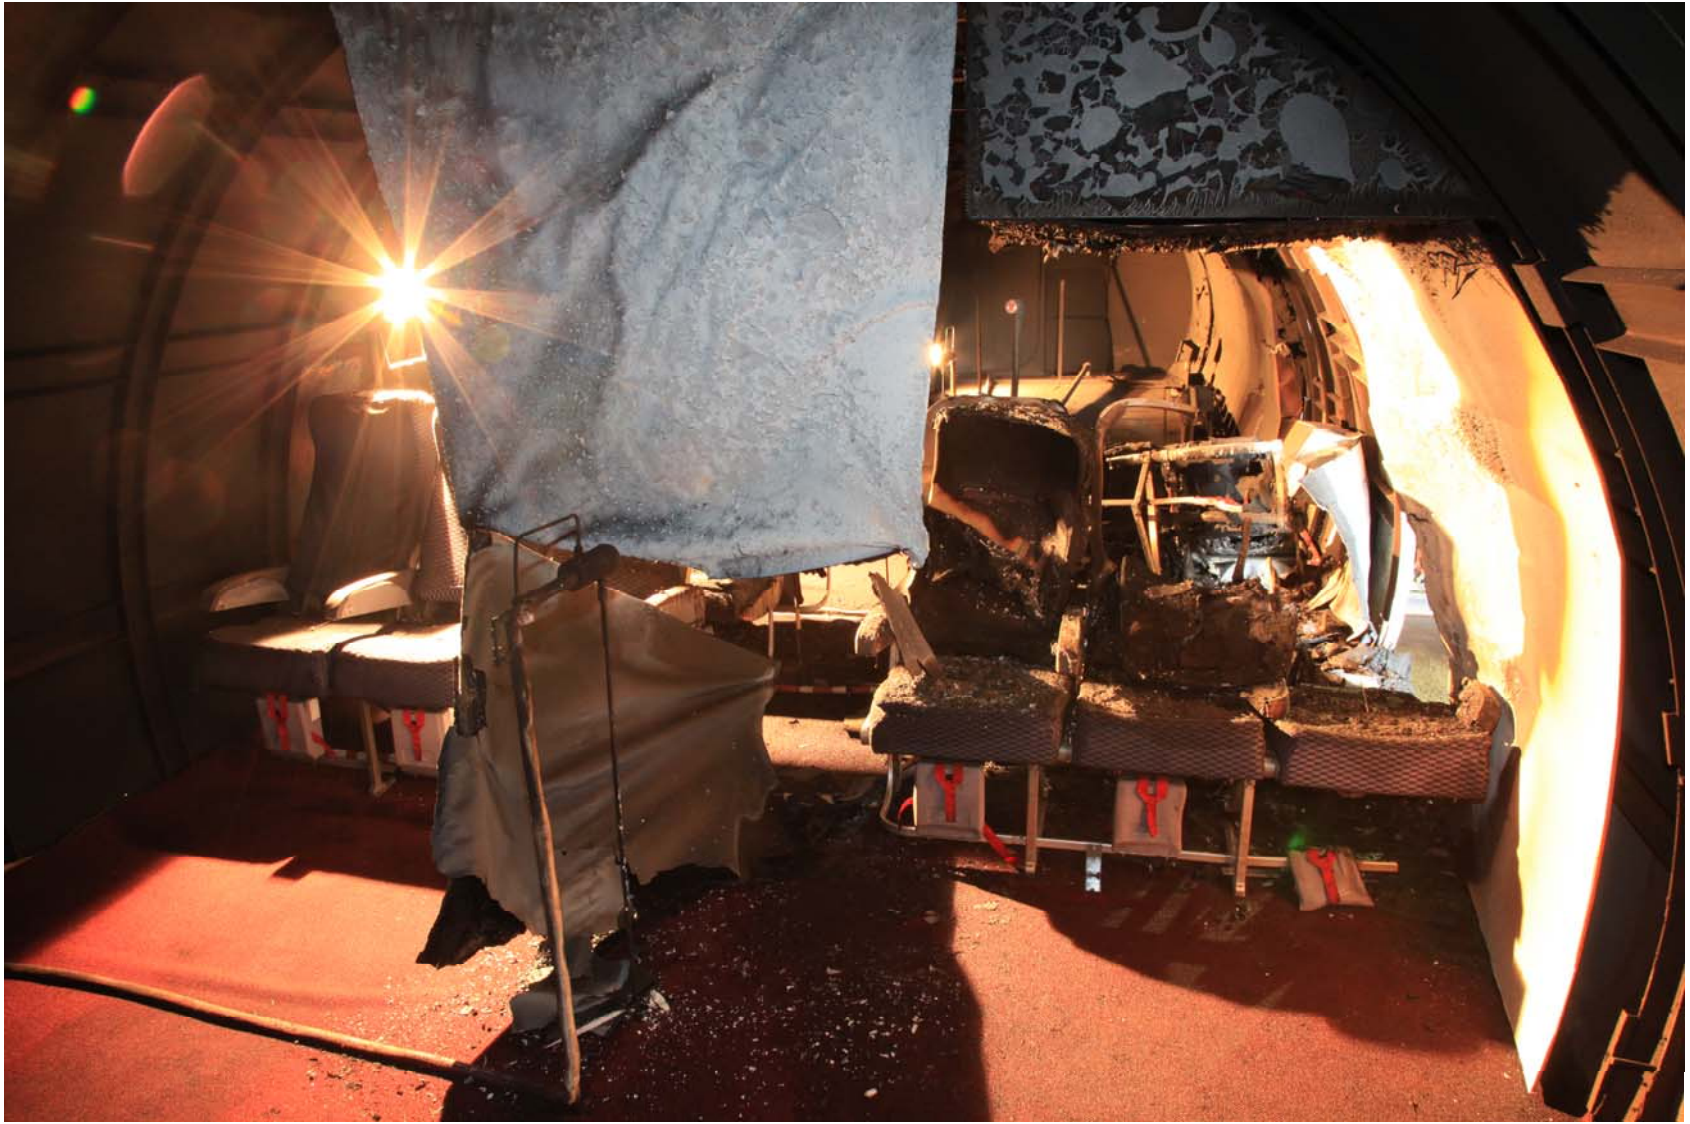
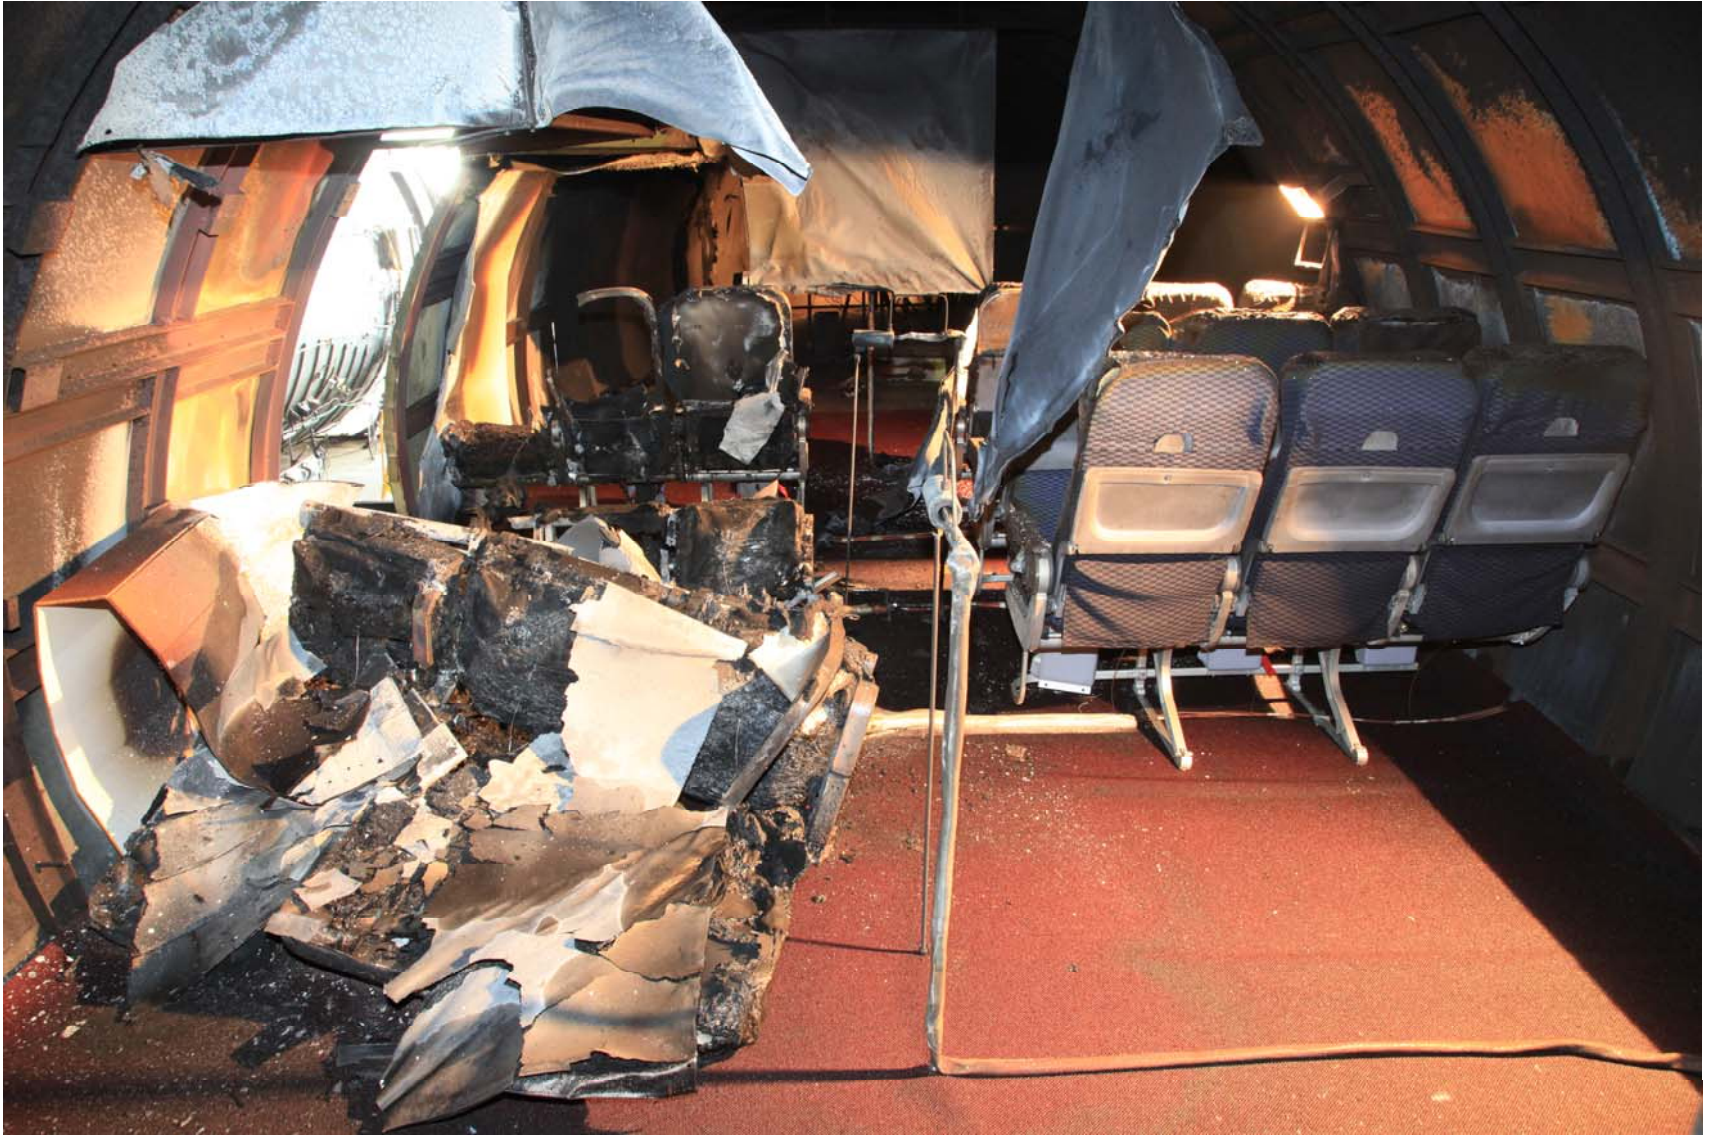
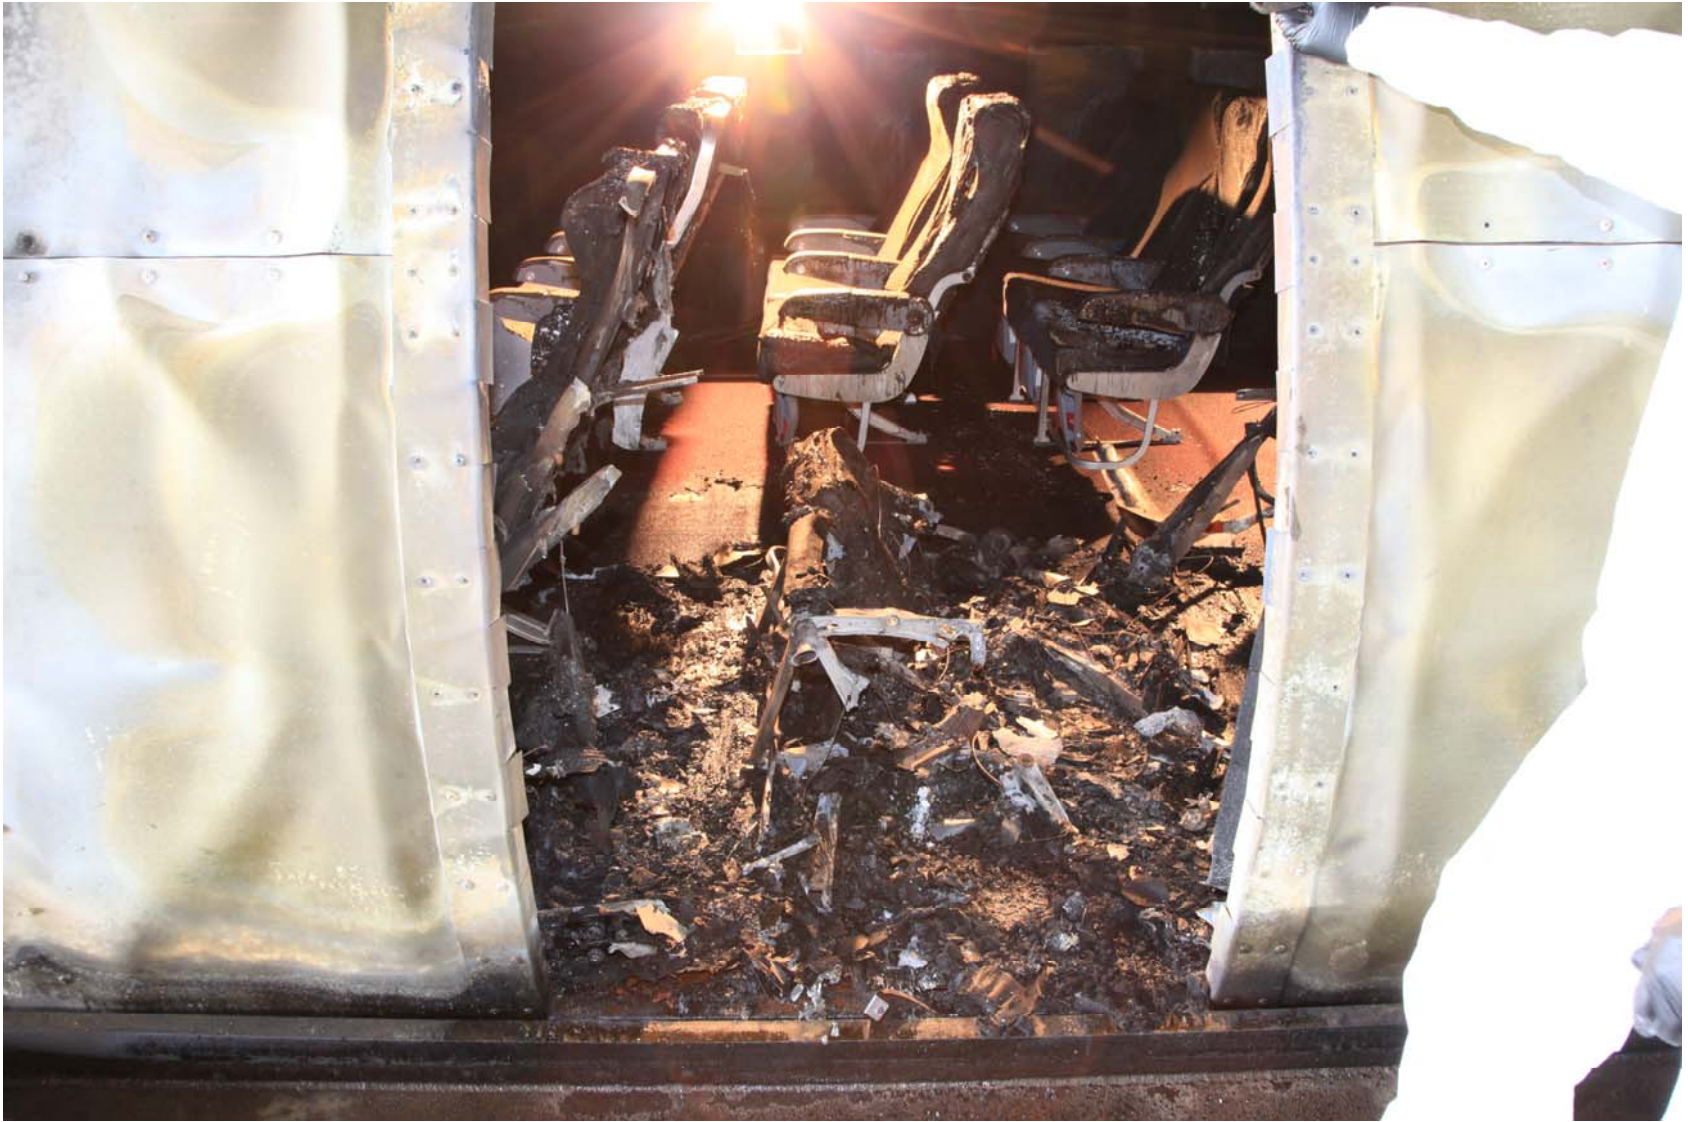
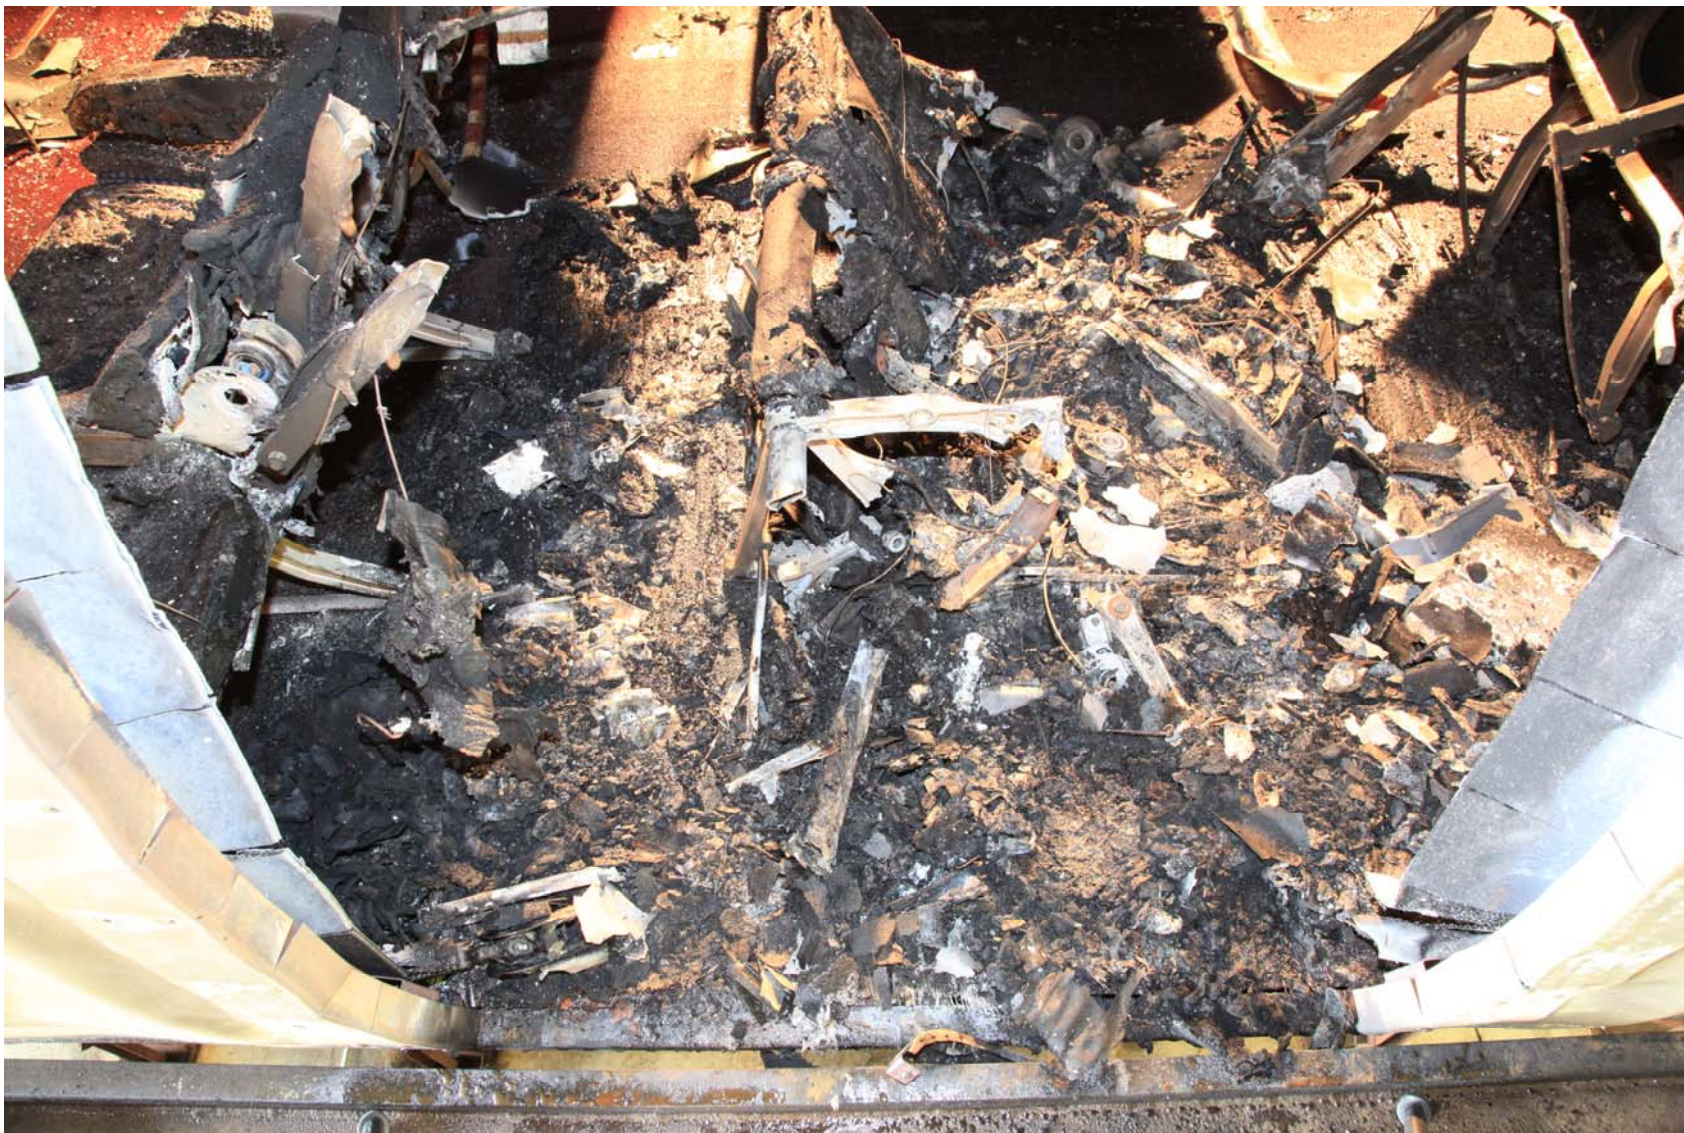
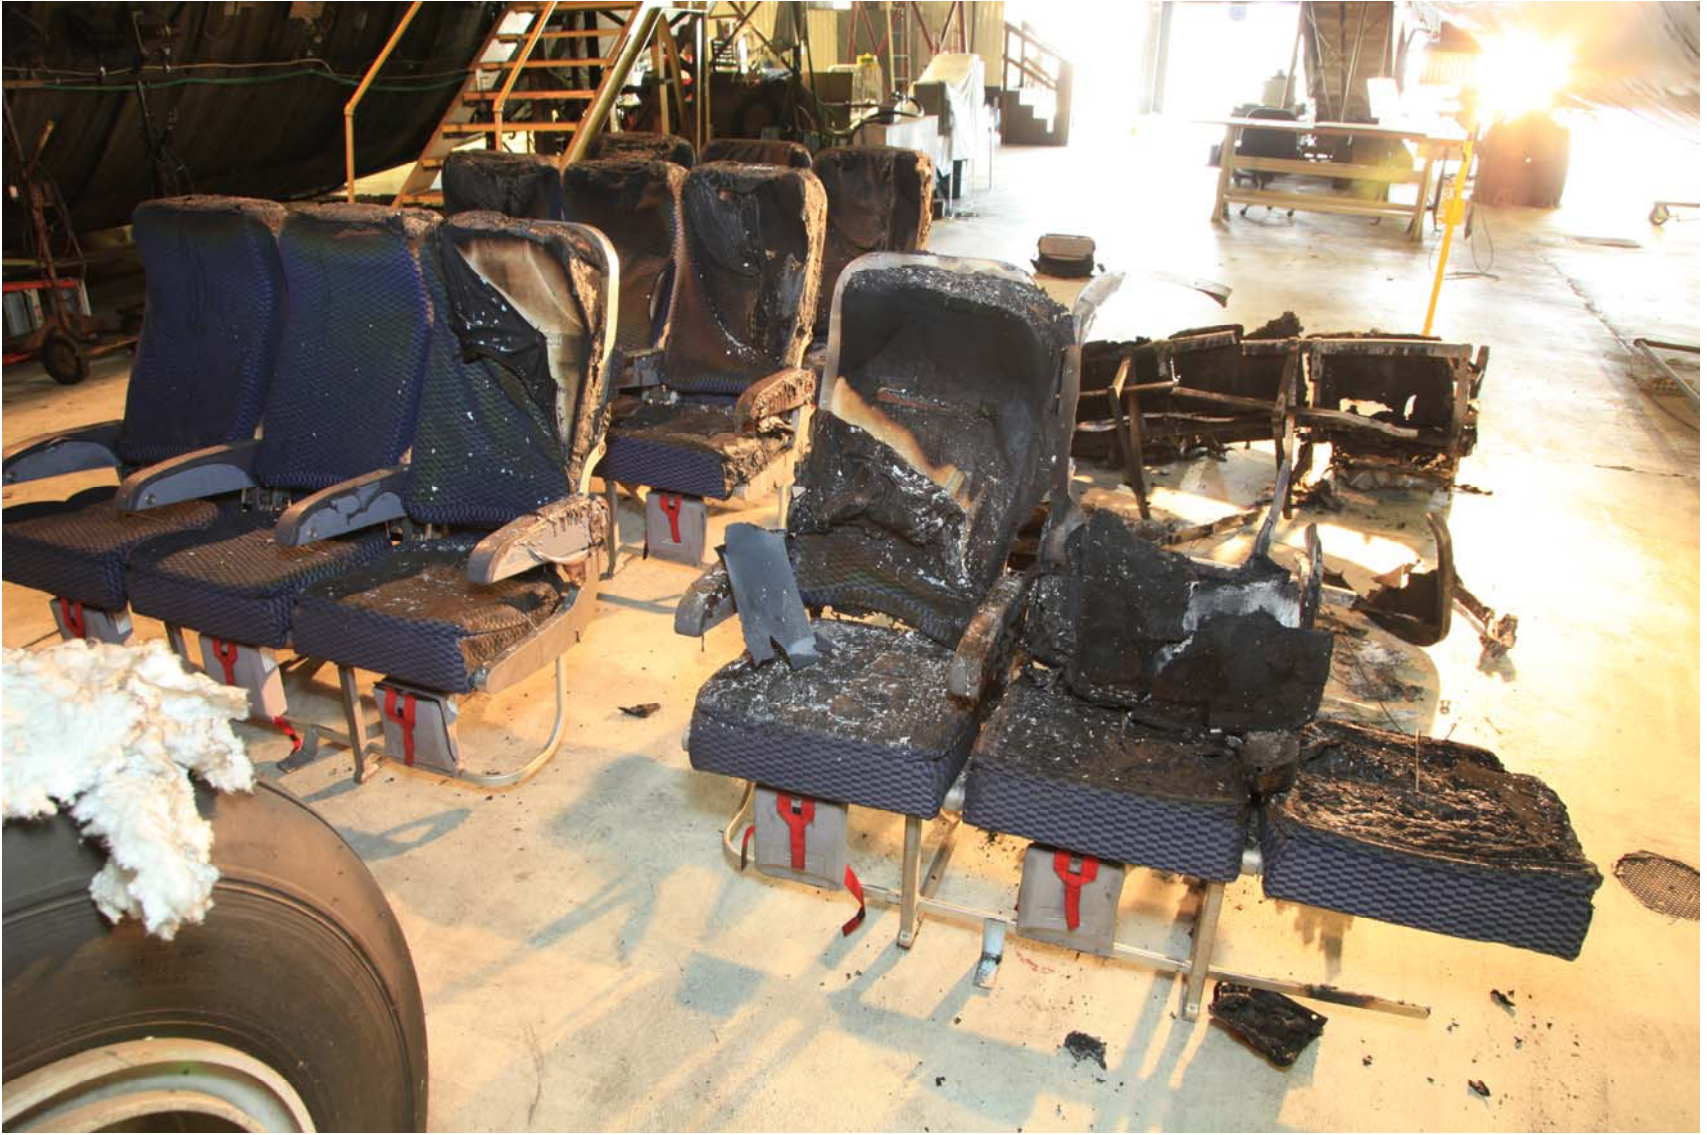
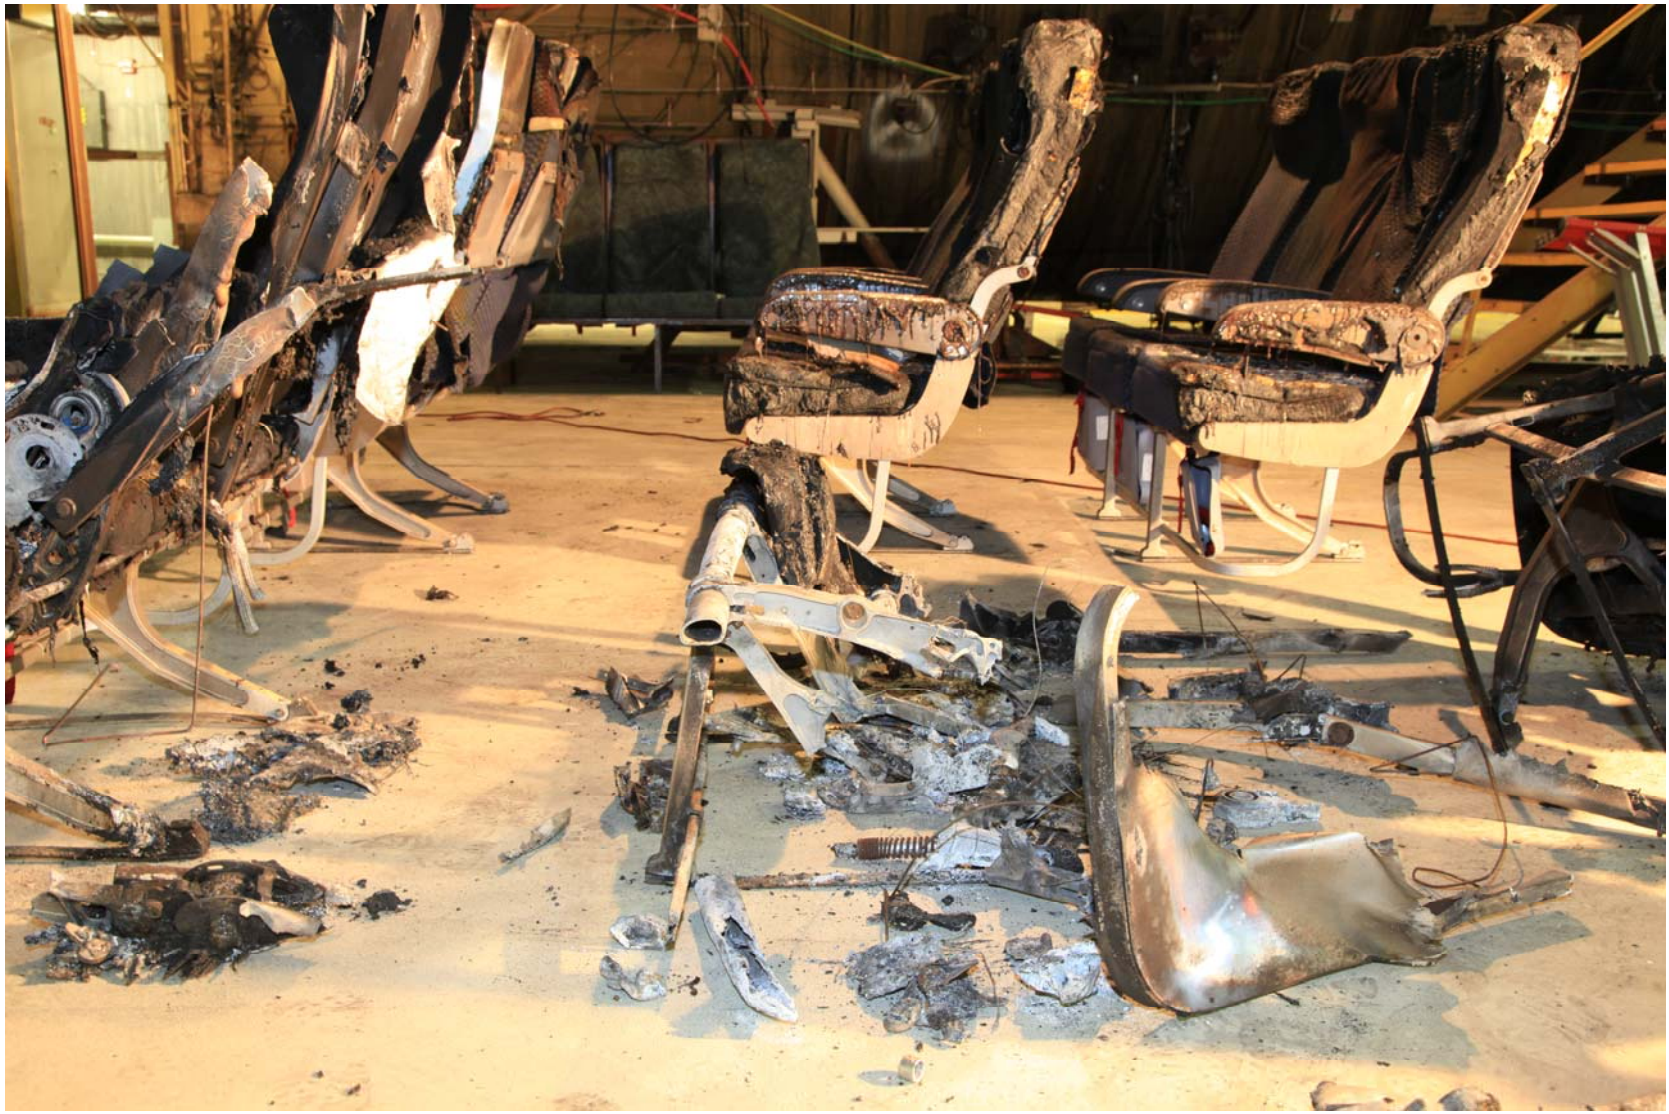
# WE-43 Test Results

Pan fire extinguished at 5 minutes using AFFF

Interior fire extinguished at 10 minutes using water

Incapacitation reached in 5 min 5 sec at forward location

Seat backs (cushions, covers, plastics) mostly consumed on port side; largely intact on starboard side

Seat bottom cushions on port side heavily involved in fire

Increased melting of primary seat structure compared to baseline 3 test
