Report No. AFAPL-TR-73-87

AEROSPACE VEHICLE HAZARD PROTECTION TEST PROGRAM: DETECTORS; MATERIALS; FUEL VULNERABILITY

FEBRUARY 1974

FINAL REPORT

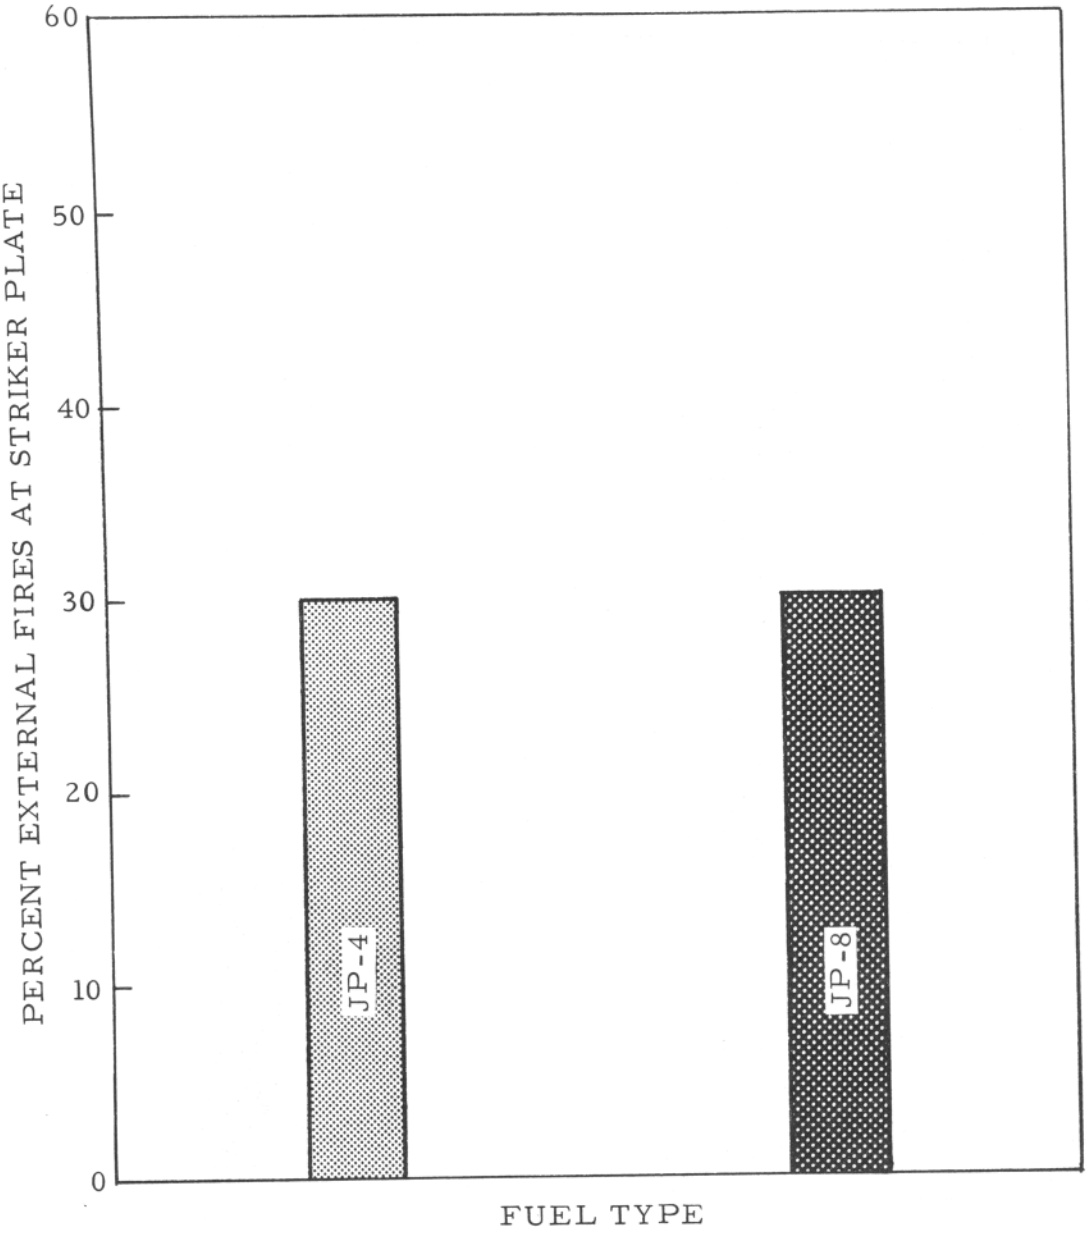
FIGURE 18. COMPARISON OF JP-4 AND JP-8 EXTERNAL FIRES

The general conclusion (see Reference 2) developed thru the analysis of the combined horizontal gunfire test data was that JP-8 is less susceptible to fire and explosion induced by gunfire and structural damage should be less when compared to JP-4.

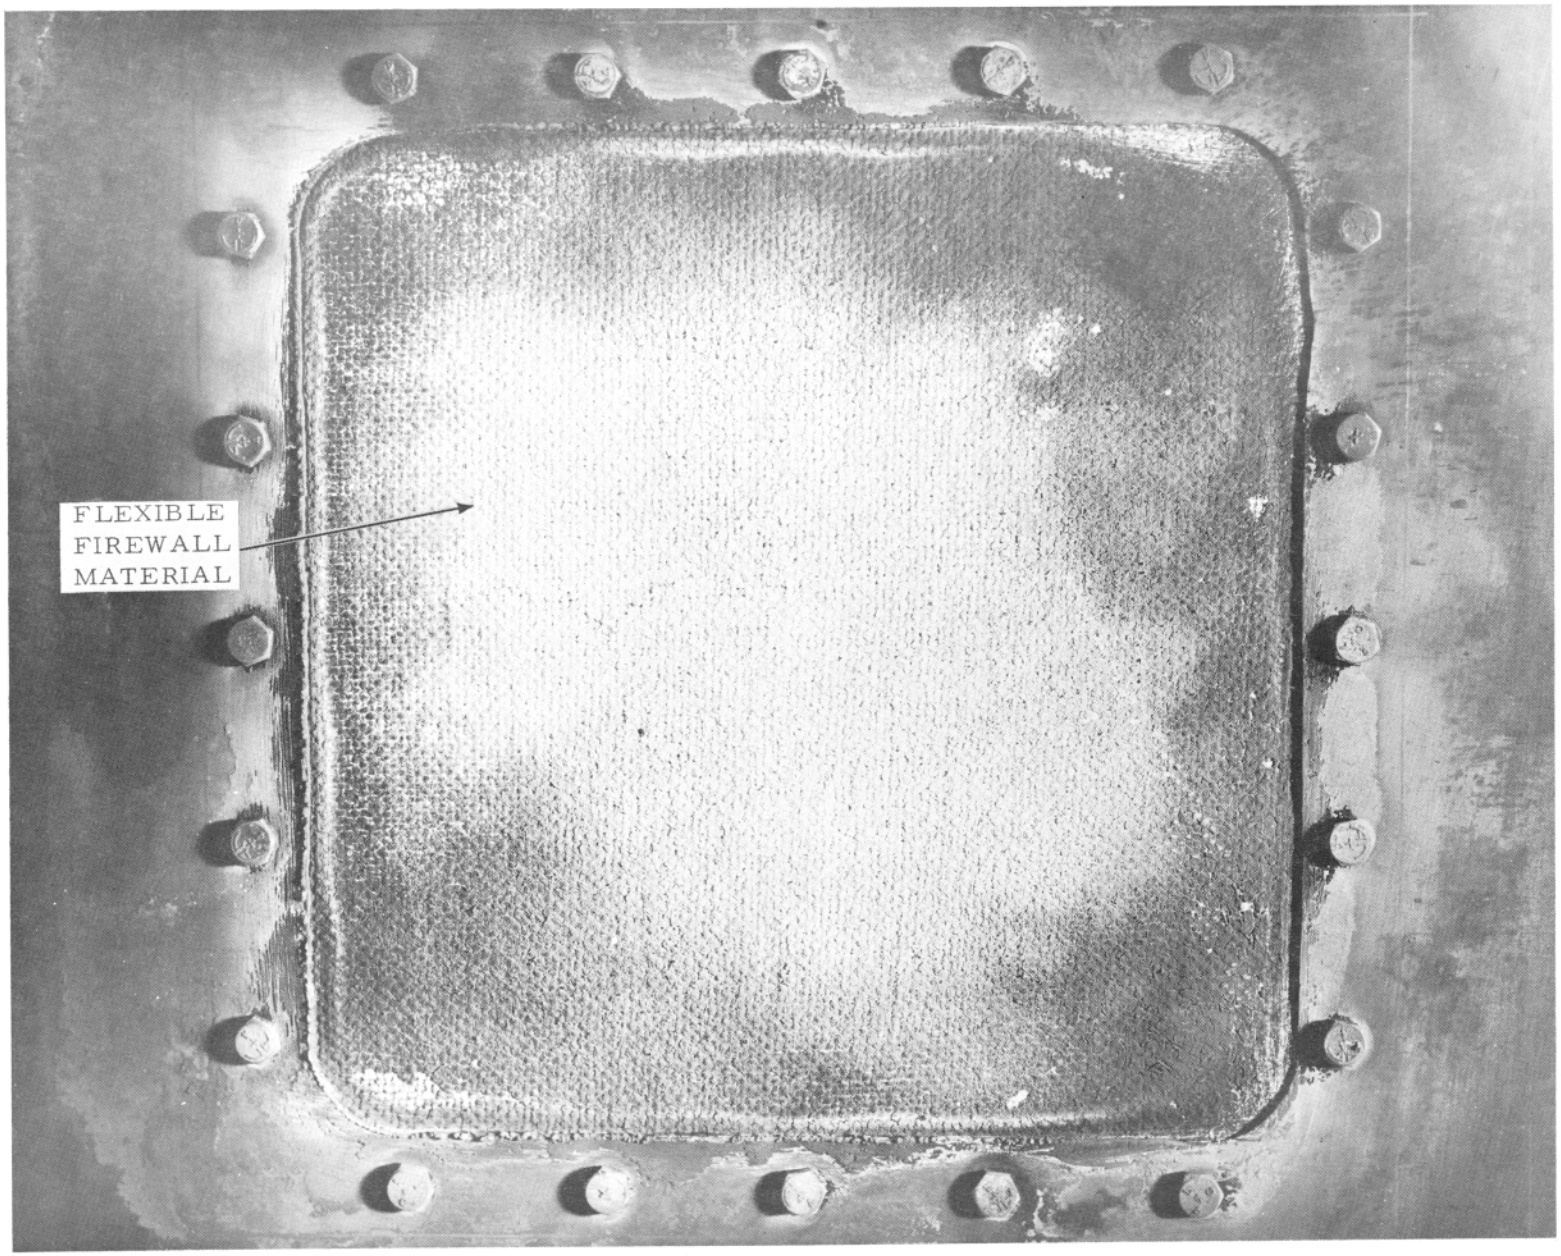
FIGURE 9. FIREWALL MATERIAL AFTER 2,000°F TESTS

Exposure Time	Remarks
15 sec	Heavy grey smoke began emitting from back-side material.
30 sec	Backing material started to turn dark grey.
45 sec	A red glow appeared on the back side.
1 min 30 sec	Particles of asbestos started falling from the front side.
2 min	The metal frame which held the specimen started glowing red.
3 min 30 sec	Two or three small pinholes appeared in material, but there was no flame penetration observed.
5 min	Smoke from specimen had almost completely subsided.
11 min	More particles were observed falling from the front side.
15 min	Approximately 12 very small pinholes could be seen in the specimen, but no flame penetration was observed.
	When the burner was removed, 1- to 2-inch long tears in three areas were observed on the aluminized side of the test specimen.

An aluminized asbestos-faced flexible firewall backed with a silicone fiberglas cloth was subjected to a 2000°F flame from the 2 gallon-per-hour kerosene standard burner. The firewall material weighed 0.4 pound per square foot and was 1/8 to 3/16 inches in thickness.

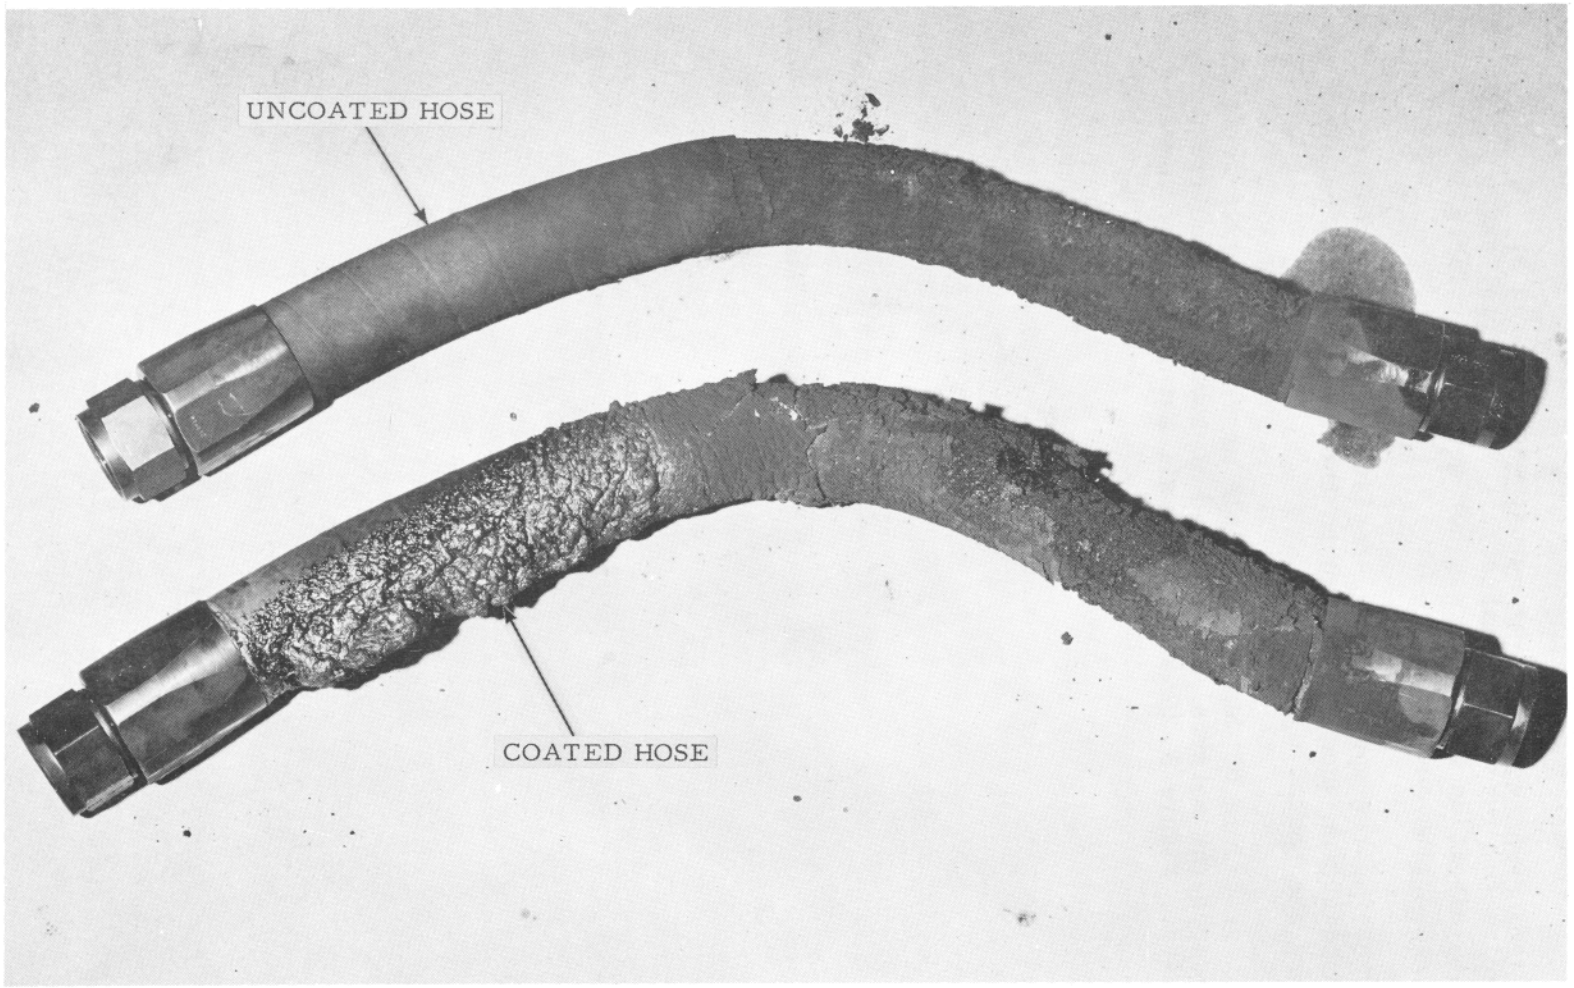
FIGURE 8. DAMAGE TO HOSE SPECIMENS

Neither hose met the test criteria for fire resistance, i.e., 5-minute exposure to the 2,000°F flame of the standard burner, even though the actual test requirements were less stringent than those required by ARP 1055. However, the intumescent paint coating did provide an additional 2 minutes and 16 seconds protection for the original hose. Figure 8 shows the hose specimens which were subjected to the standard burner during these tests.
